Underwater Bridge Inspection Report

Douglas MacArthur Bridge

Over the Detroit River

April 22, 2009

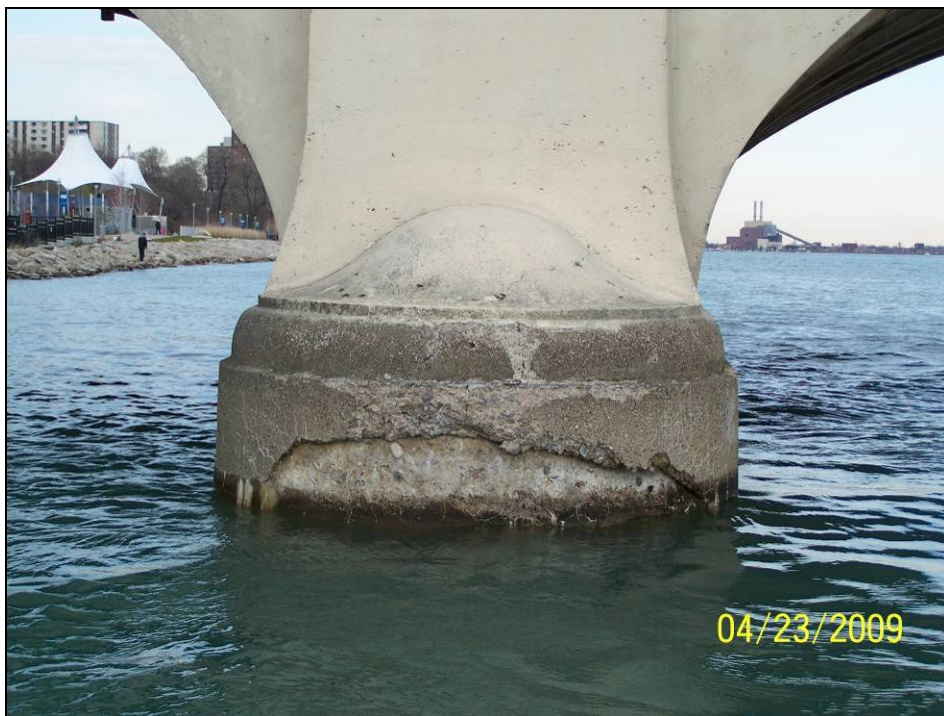
A 6 to 10 foot diameter mound of silt infilling, approximately 1 to 2 feet higher than the surrounding channel bottom, was observed at the northwest corner of the pier. Based on depth soundings, a scour pocket was present at the upstream nose and was likely 10 feet in diameter and approximately 1 to 3 feet deep. Vertical 12 inch by 12 inch timbers protruded up from the channel bottom 4 feet at the northeast corner of the pier. As described in the general notes, occasional horizontal timber members protruded from faces of the pier near the channel bottom. Located 5 feet downstream of the northeast corner, two areas of section loss measuring 1 to 1.5 feet in diameter were centered at 1 foot above the waterline and at 3.5 feet above the waterline. These areas of section loss had 2 to 3 inches of penetration. Refer to Photograph 89 in Appendix B for a view of the section loss near the northeast corner. A similar area of section loss was also noted at the northwest corner. Refer to Photograph 90 in Appendix B for a view of the section loss at the northwest corner. At the downstream nose an area of section loss extended from 6 inches below the waterline to 2.5 feet above the waterline and was 8 to 10 feet wide, with 4 to 8 inches of penetration. Refer to Photograph 10 in Appendix B for a view of the downstream nose.

Photograph 10. View of Pier 1 Downstream Nose.

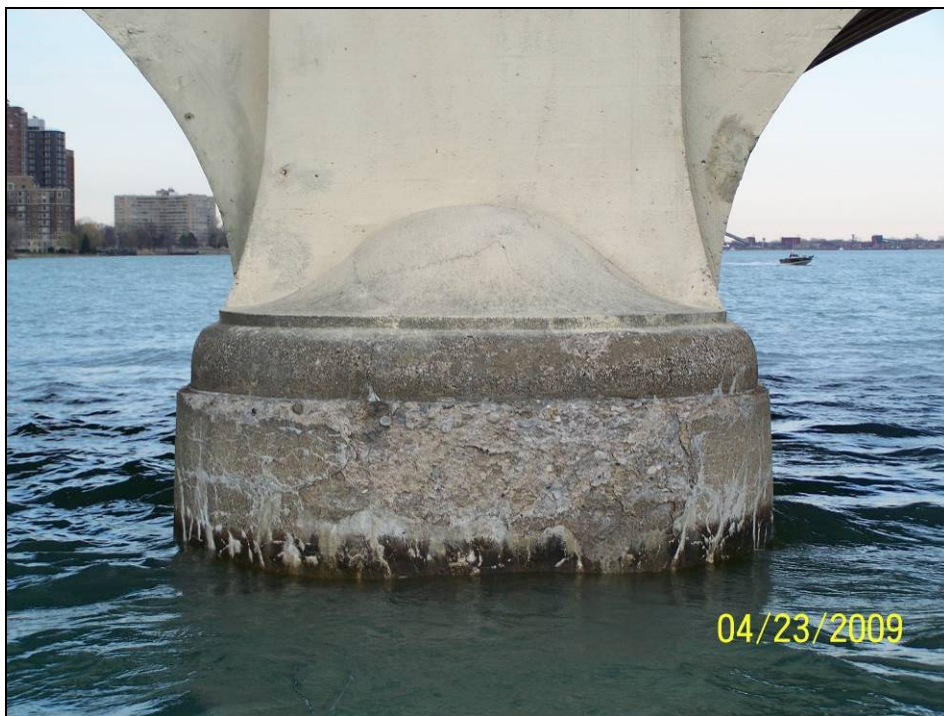
out from the faces of the pier within the upstream quarter of the pier, near the channel bottom. At the downstream nose of the pier a horseshoe shaped scour pocket extended from the nose out 4 feet. The scour pocket was 6 to 10 inches deeper than the adjacent downstream channel bottom elevations and 3 feet deeper than the adjacent upstream channel bottom elevations. Light hairline cracking was observed over the upstream nose, most of which was horizontally oriented. The cracking extended from 1 foot to 3 feet above the waterline for a width of 6 feet. Efflorescence was present at the cracks. Refer to Photograph 13 in Appendix B for a view of the upstream nose. A 2 foot diameter area of section loss was located 15 feet downstream of the southeast corner and was center at 2 feet above the waterline, with 2 to 3 inches of penetration. Refer to Photograph 91 in Appendix B for a view of the section loss. The downstream nose exhibited section loss for a width of 8 feet which extended from 1 foot to 3 feet above the waterline, with penetrations of 3 to 6 inches. In addition, hairline to 1/2 inch wide map cracking was observed over the downstream nose from 6 inches below the waterline to 6 feet above the waterline. The region between 4.5 feet above the waterline and 6 feet above the waterline at both the upstream and downstream noses consisted of a rounded decorative cap. Refer to Photograph 14 in Appendix B for a view of the downstream nose.

Photograph 14. View of Pier 2 Downstream Nose.

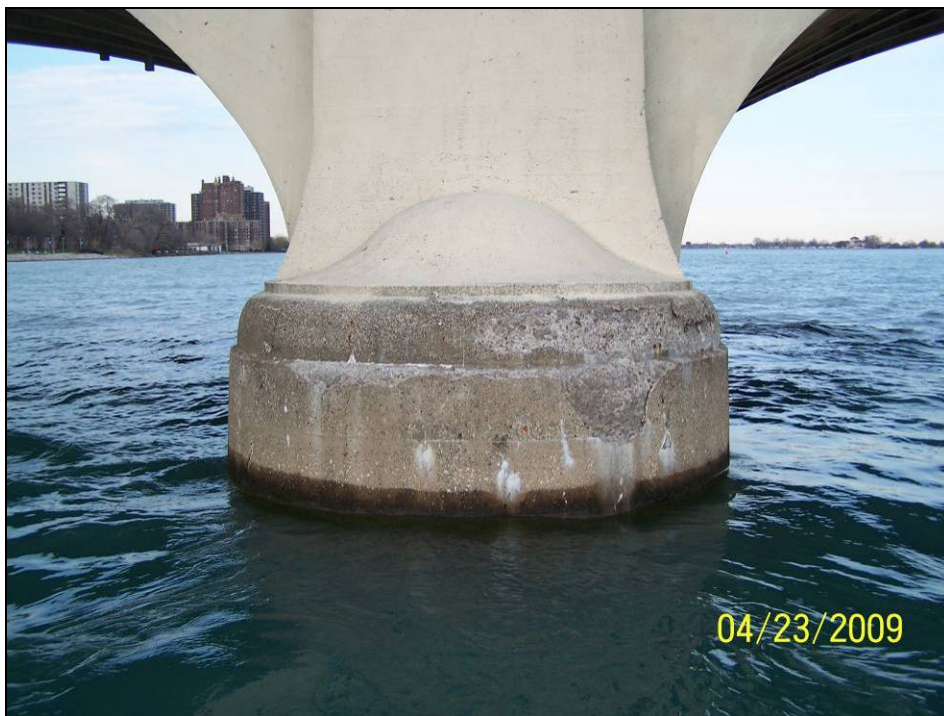
and across the upstream nose, to the downstream quarter point on the south face. As described in the general notes, horizontal timbers protruded from the faces of the pier near the channel bottom. An area of section loss was noted on the south face, 15 feet upstream of the southwest corner. The area was 3 feet long by 1.5 feet high with 2 to 3 inches of penetration and was centered at 3.5 feet above the waterline. Refer to Photograph 92 in Appendix B for a view of the section loss. The downstream nose had section loss over 25 percent of the surface area from 1.5 feet above the waterline to 4.5 feet above the waterline. The section loss extended for a width of 10 feet and had penetrations ranging from 2 to 3 inches. Refer to Photograph 18 in Appendix B for a view of the downstream nose.

Photograph 18. View of Pier 3 Downstream Nose.

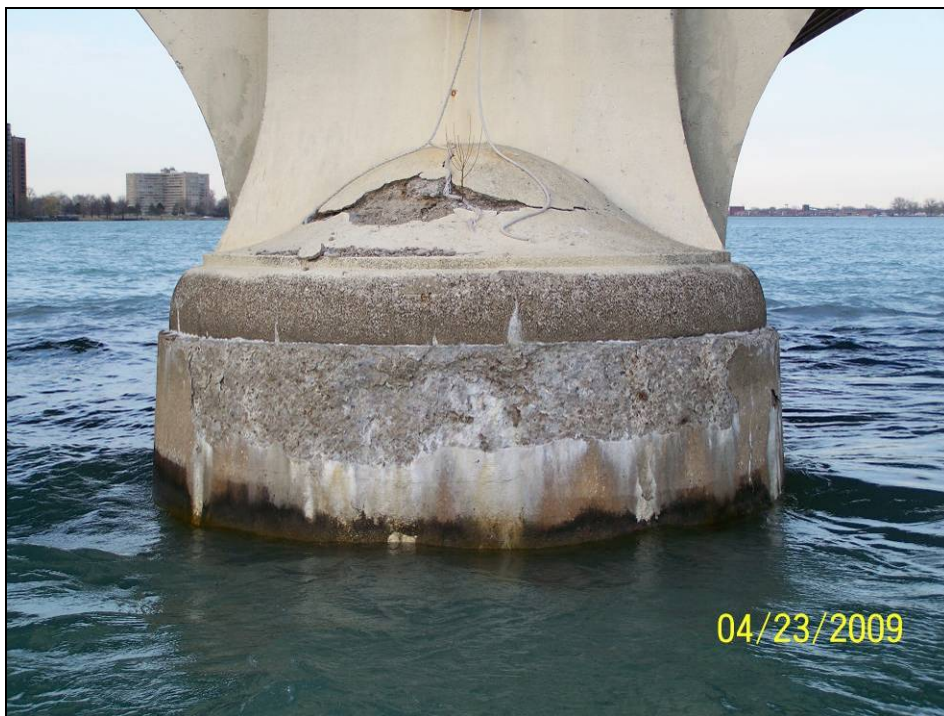
Based on depth soundings and observed footing exposure, a 4 to 6 foot deep scour pocket was present at the upstream nose and downstream along both faces to the upstream quarter points. The scour extended out from the pier nose and faces 10 to 15 feet. As a result, the lower tier of the footing was exposed from the upstream quarter point on the north face, around the northeast corner, to the center of the upstream face. The lower tier of the footing was vertically exposed for 1 foot at the northeast corner and was flush with the channel bottom at the center of the upstream face. The upper tier of the footing was exposed from the upstream quarter point on the north face, around and across the upstream nose, to the upstream quarter point on the south face. At the southeast corner, the upper tier of the footing had 2 feet of vertical exposure. Extending from the upstream nose were two rows of 12 inch by 12 inch horizontal timbers pointing downstream and away from the pier at a 45 degree angle. The timbers were located between 1 foot and 3 feet above the top of the upper tier of the footing. In addition, approximately four rows of horizontal 12 inch by 12 inch timbers were found protruding from pier walls on both the north and south faces, near the channel bottom. Section loss was observed on 75 percent of the surface area of the upstream nose between 1 foot and 4.5 feet above the waterline, for a length of 8 to 10 feet. Penetrations ranged from 3 to 4 inches. Refer to Photograph 25 in Appendix B for a view of the upstream nose. A 1 foot diameter area of section loss was noted at the waterline near the northeast corner of the pier, with 3 to 4 inches of penetration. The downstream nose exhibited section loss from 1.5 feet to 3 feet above the waterline for a length of 10 to 12 feet and had penetrations of 3 to 4 inches. In addition, the decorative cap at the downstream nose had an area of section loss centered at 5.5 feet above the waterline

that measured 5 feet long by 1.5 feet high. The area of section loss had 4 inch deep penetrations and associated 1/2 inch wide cracking. Refer to Photograph 26 in Appendix B for a view of the downstream nose.

Photograph 26. View of Pier 5 Downstream Nose.

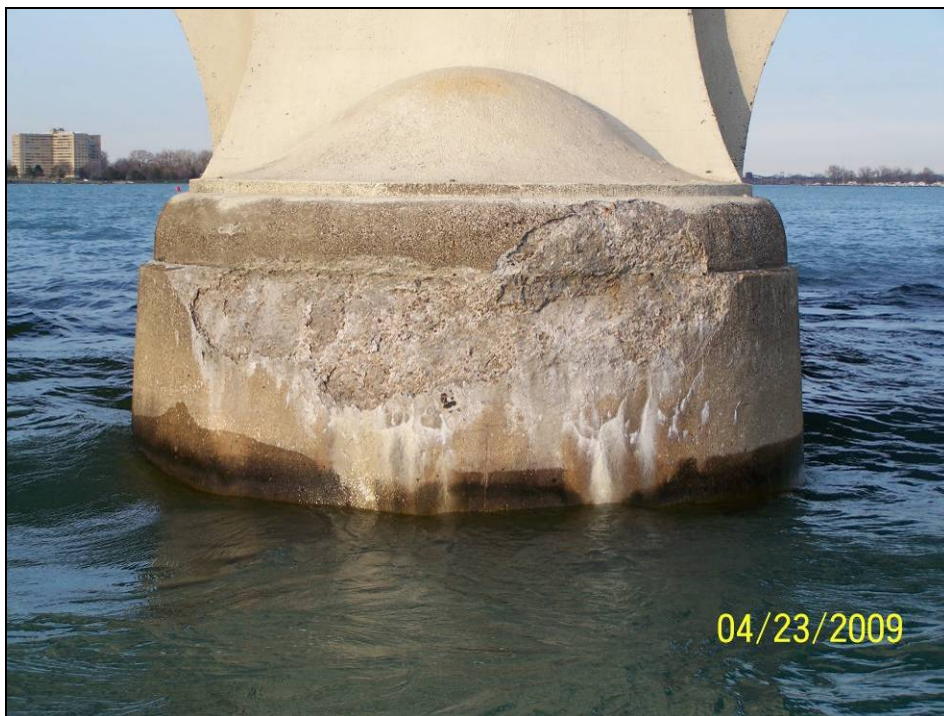
Based on depth soundings, a 5 to 6 foot deep scour pocket was present at the upstream nose and was approximately 12 feet in diameter. However, no footing exposure was detected. Channel bottom infilling was noted adjacent to the downstream nose. The channel bottom in this vicinity sloped down and away from the pier nose at an approximate slope of 1:1. Pheumo-fathometer readings indicated that the channel bottom near the downstream nose was 20 feet and that it dropped down and away to a depth of 26 feet. Depth soundings recorded a depth of 26.5 feet in this area. Extending from the northeast corner of the upstream nose were two rows of 12 inch by 12 inch horizontal timbers pointing downstream and away from the pier at a 45 degree angle. As described in the general notes, five sets of horizontal timbers protruded from the north face of the pier near the channel bottom. A 10 inch diameter log was noted on the channel bottom at the northeast corner of the pier and extended downstream and away from the pier at a 45 degree angle. Timber formwork ranging in size from 4 to 12 inches was noted on the channel bottom near the upstream nose and extending south towards Pier 7. Section loss was noted over 50 percent of the surface area of the entire upstream nose from 1.5 feet to 4.5 feet above the waterline. This area exhibited penetrations of 3 to 6 inches. In addition, associated hairline to 1/4 inch wide map cracking and concrete delaminations extended to the decorative cap. Refer to Photograph 29 in Appendix B for a view of the upstream nose. The downstream nose had section loss over 75 of the surface area for a width of 8 to 10 feet. This area extended from 1.5 to 4.5 feet above the waterline and had penetrations ranging from 4 to 6 inches. Refer to Photograph 30 in Appendix B for a view of the downstream nose.

Photograph 30. View of Pier 6 Downstream Nose.

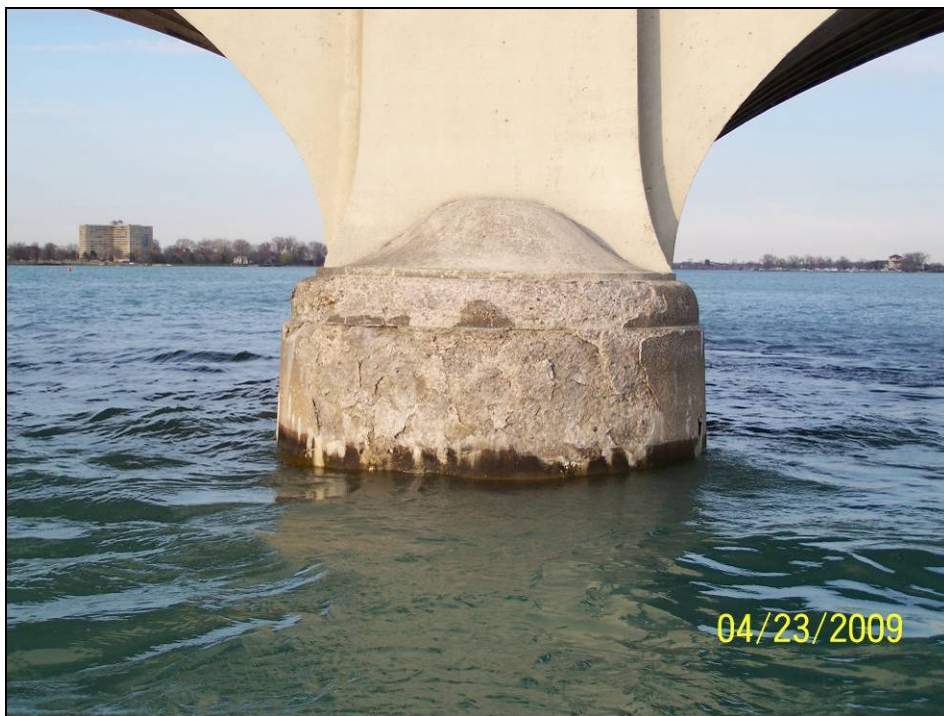
observed, was noted over 95% of the surface area of the downstream nose from the waterline to 4.5 feet above the waterline. Penetrations ranged from 6 inches up to 12 inches. The area of section loss had associated hairline to 1/8 inch wide map cracking and concrete delaminations. Refer to Photograph 34 in Appendix B for a view of the downstream nose.

Photograph 34. View of Pier 7 Downstream Nose.

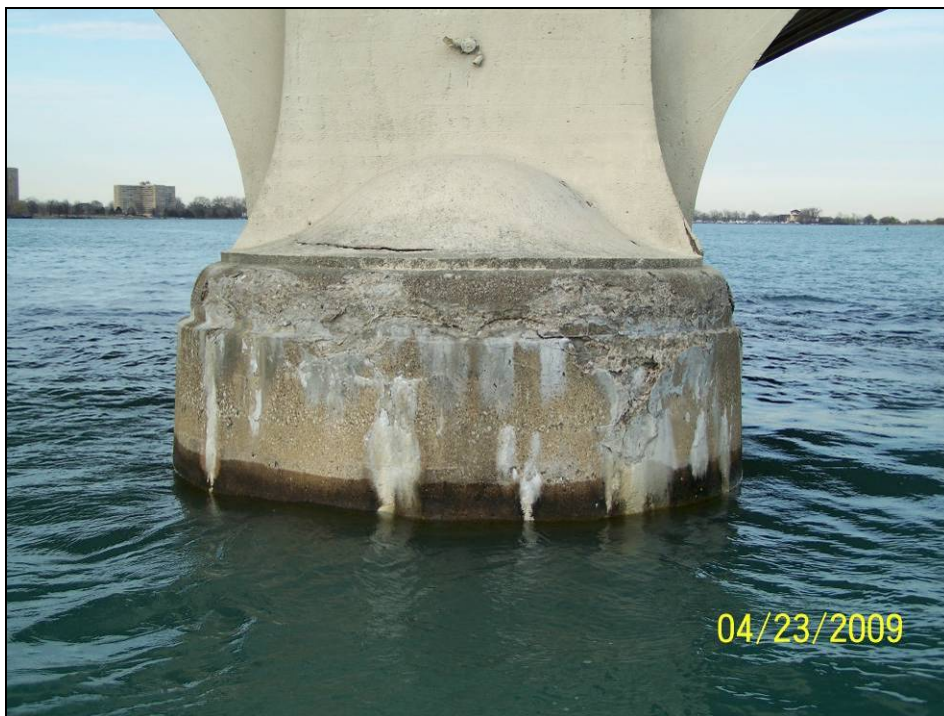
Based on depth soundings and observed footing exposure, a 4 to 8 foot deep scour pocket was observed around the upstream, along the entire south face, and around the downstream nose. The scour extended out from the face and the noses 8 to 12 feet. The upper tier of the footing became exposed 2 feet north of the centerline of the pier at the upstream nose. The footing exposure increased such that there was 1 foot of vertical exposure at the centerline of the pier at the upstream nose. At the southeast corner of the footing there was 1.5 feet of vertical exposure. The vertical exposure continued down the south face to the southwest corner and was 1 foot high. At the centerline of the pier at the downstream nose the footing became buried in the channel bottom. No footing exposure was observed along the north face of the pier nor was any lower tier footing exposure detected. As described in the general notes, along the south face of the pier horizontal timbers were protruding from the face, near the channel bottom. The decorative cap at the downstream nose had a 1 inch wide horizontal crack that was 8 feet long located at 5 feet above the water line. Refer to Photograph 96 in Appendix B for a view of the horizontal crack. The downstream nose had section loss over 75 percent of the surface area from 2.5 feet to 4.5 feet above the waterline with 2 to 6 inches of penetration. Refer to Photograph 38 in Appendix B for a view of the downstream nose.

Photograph 38. View of Pier 8 Downstream Nose.

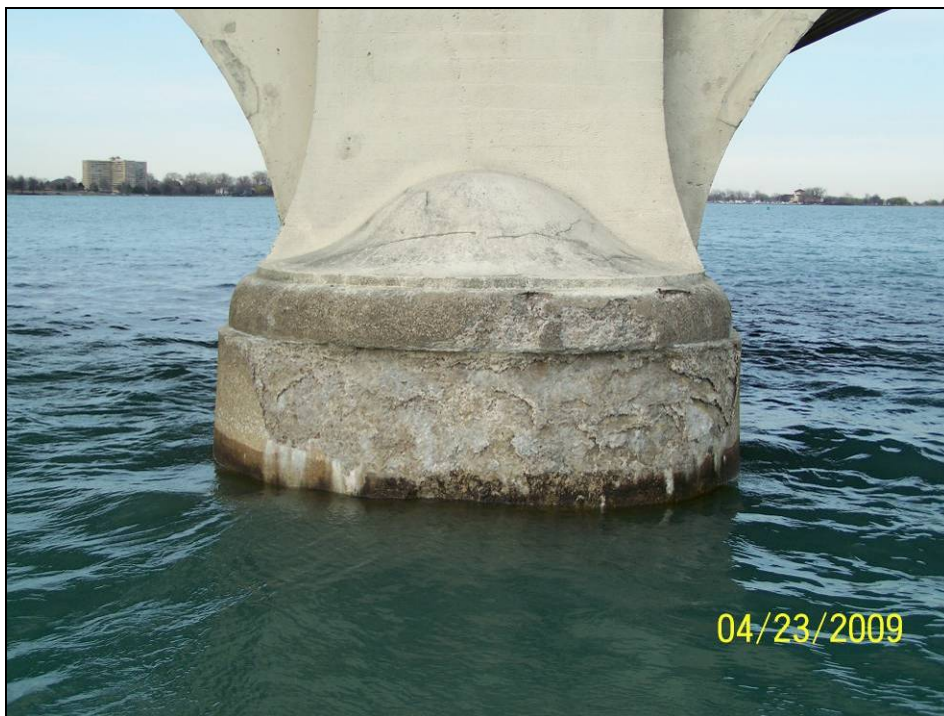
Based on depth soundings and observed footing exposure, a 6 to 8 foot deep scour depression was present at the upstream nose and extended downstream along both faces for 10 to 15 feet. The scour depression extended out from the nose and faces for 8 to 12 feet. The lower tier of the footing was exposed 10 feet downstream of the northeast corner, around and across the upstream face, to the southeast corner. The lower tier of the footing had 1.5 feet of vertical exposure at the northeast corner and at the center of the upstream face, while the southeast corner was flush with the channel bottom. The upper tier of the footing was exposed from 20 feet downstream of the northeast corner, around and across the upstream nose, to 15 to 20 feet downstream of the southeast corner. Section loss was observed for a length of 8 feet across the upstream nose from 0.5 feet to 2.5 feet above the waterline, with 2 to 4 inches of probe rod penetration. Refer to Photograph 41 in Appendix B for a view of the upstream nose. Section loss was also observed on the downstream nose for a length of 10 feet, and extended from the waterline to 4.5 feet above the waterline. Penetrations ranged from 3 to 8 inches. The decorative cap at the downstream nose had 1/16 inch to 1/4 wide map cracking from 4.5 feet to 7.0 feet above the waterline. Refer to Photograph 42 in Appendix B for a view of the downstream nose and decorative cap.

Photograph 42. View of Pier 9 Downstream Nose.

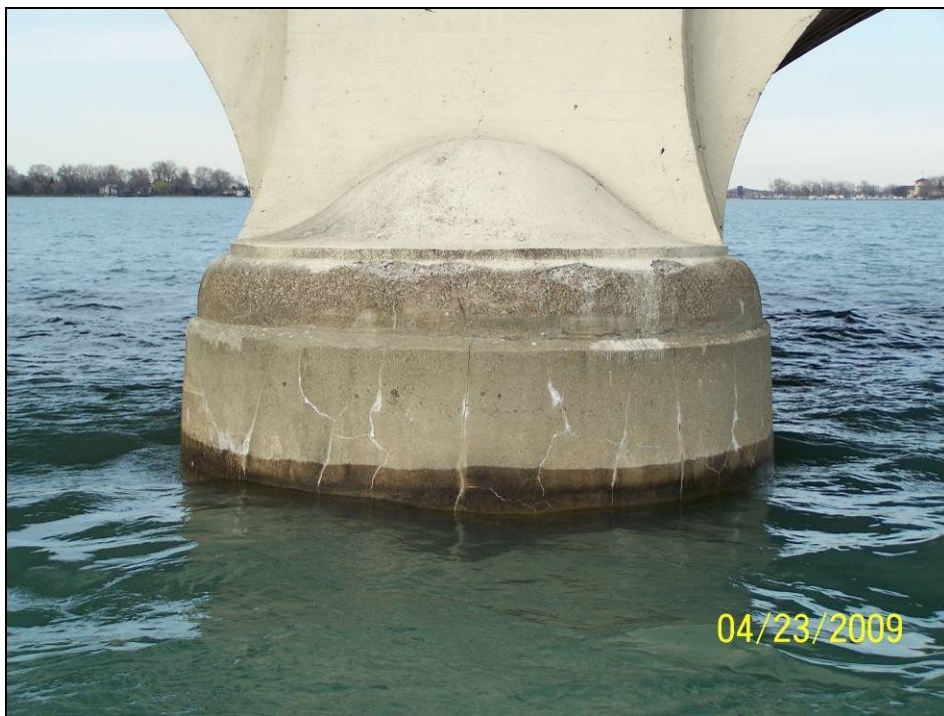
across the upstream nose, to 10 feet downstream of the southeast corner. The upstream nose had section loss over the south half from 2 feet to 4.5 feet above the waterline with 1 to 2 inches of penetration. Refer to Photograph 45 in Appendix B for a view of the upstream nose. A 5 foot long by 1 foot high area of section loss was noted 15 feet downstream of the northeast corner at 2.5 feet above the waterline. Penetrations were between 2 and 3 inches. Refer to Photograph 97 in Appendix B for a view of the section loss. The downstream nose had hairline to 1/8 inch wide map cracking with efflorescence from the waterline to 4.5 feet above the waterline. Refer to Photograph 46 in Appendix B for a view of the downstream nose.

Photograph 46. View of Pier 10 Downstream Nose.

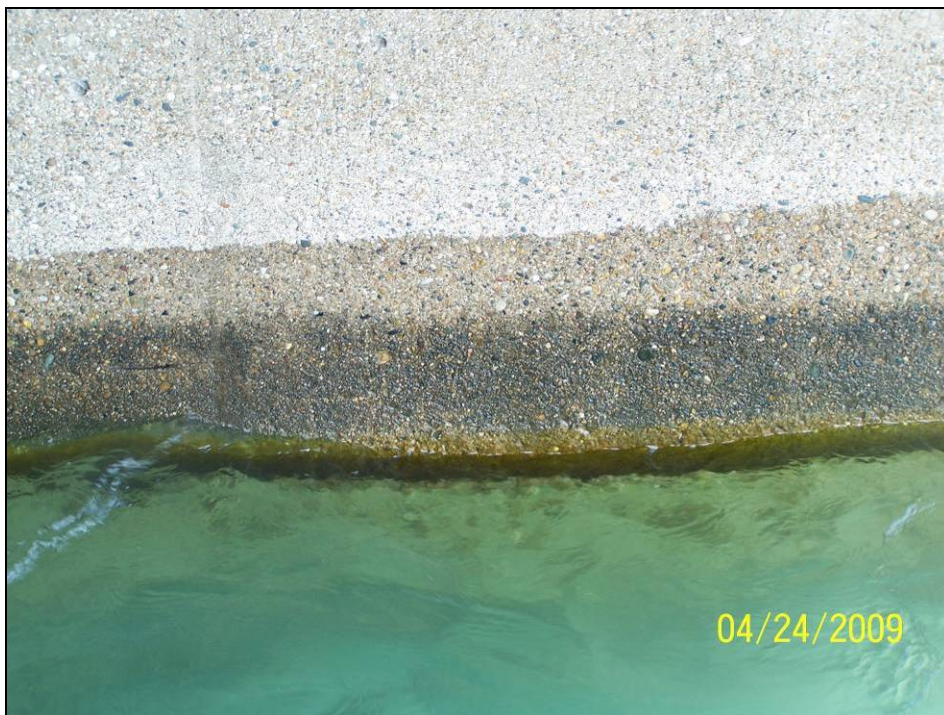
Appendix B for a view of the small areas of section loss. Refer to Photograph 88 in Appendix B for a view of the typical concrete condition near the waterline.

Photograph 88: View of Typical Concrete Condition Near the Waterline.

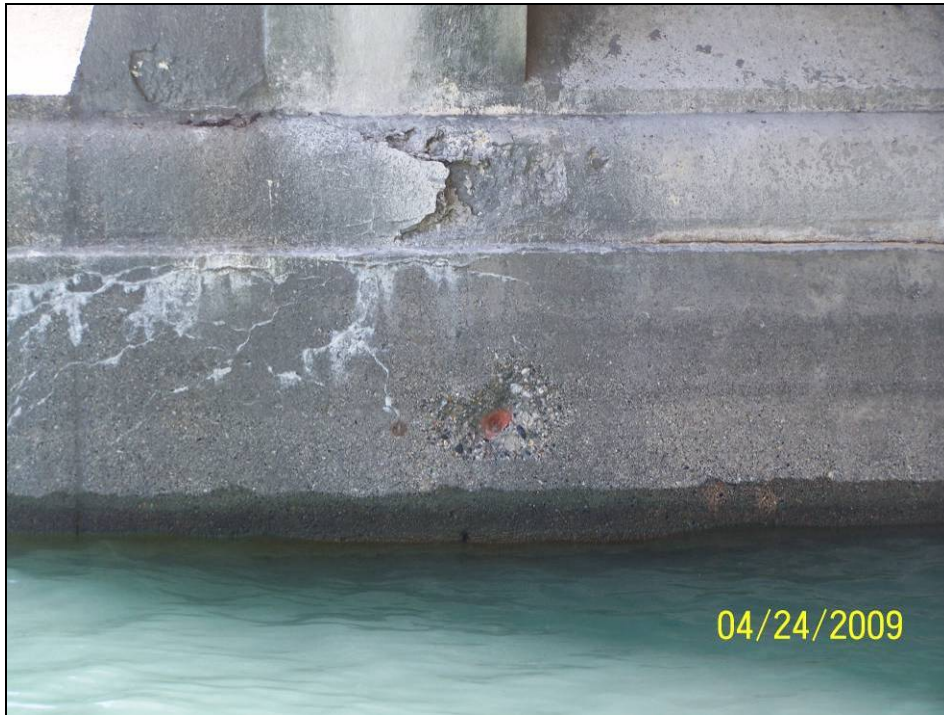
Photograph 89: View of Pier 1 Section Loss Near Northeast Corner.

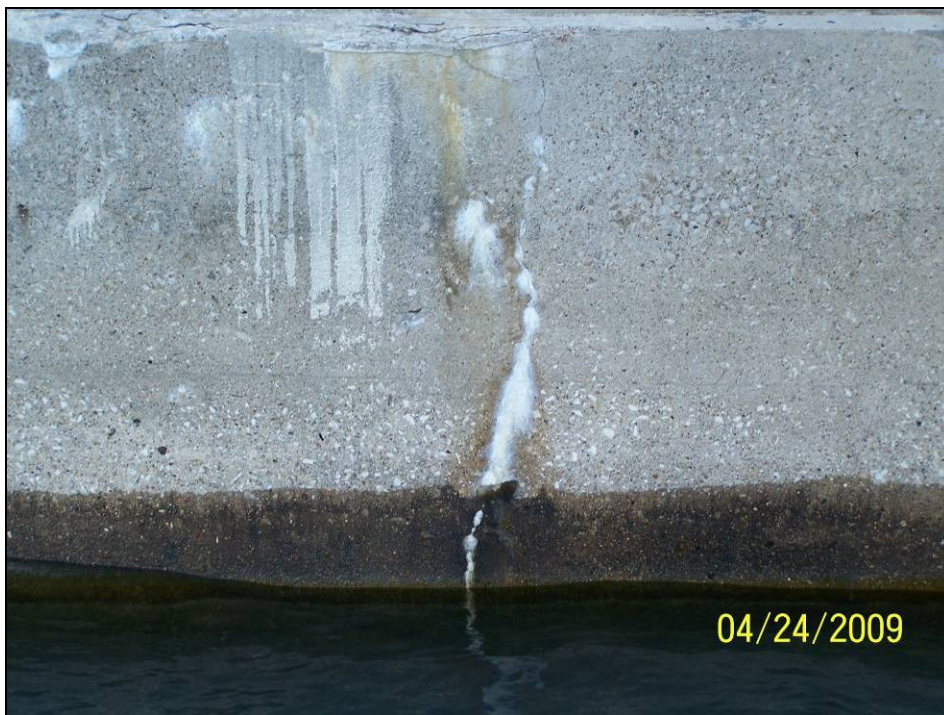
Photograph 94: View of Pier 7 Vertical Crack Near Northwest Corner.

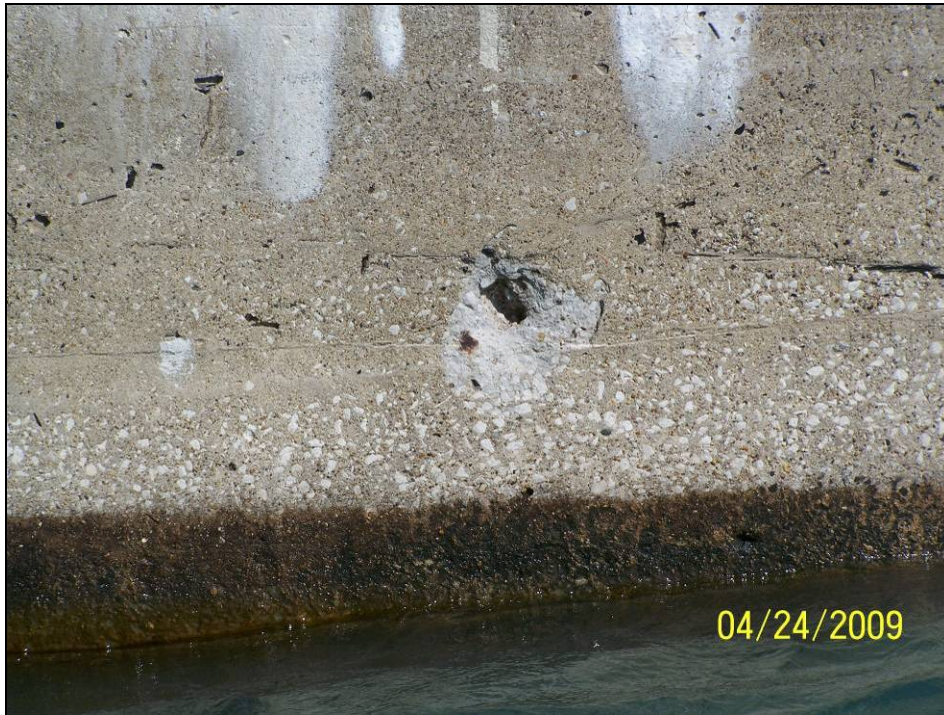
Photograph 95: View of Pier 7 Section Loss on South Face.

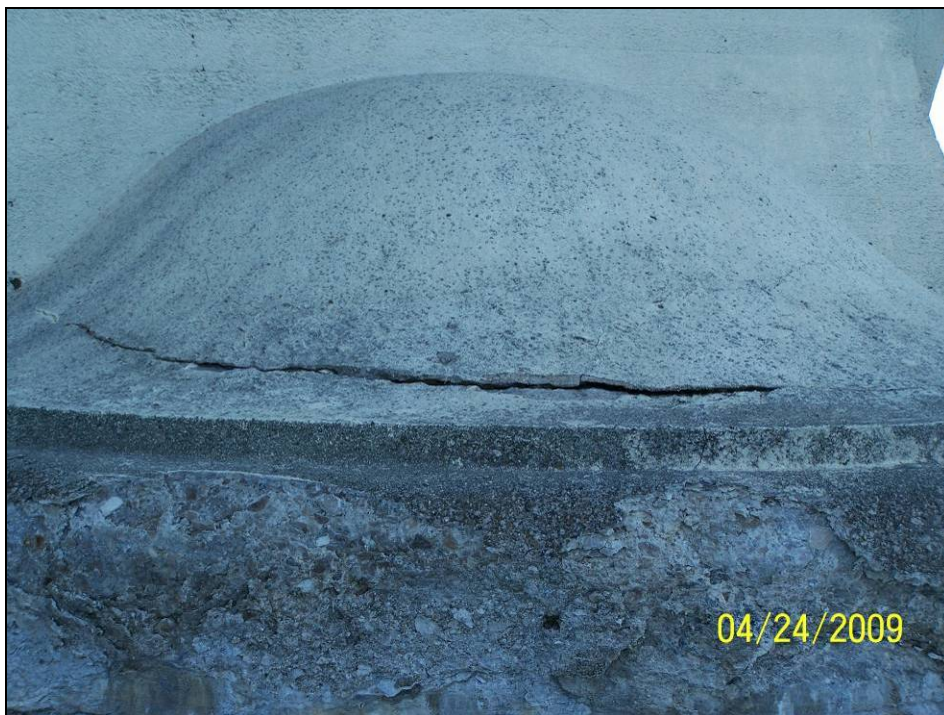
Photograph 96: View of Pier 8 Horizontal Crack on Downstream Decorative Cap.

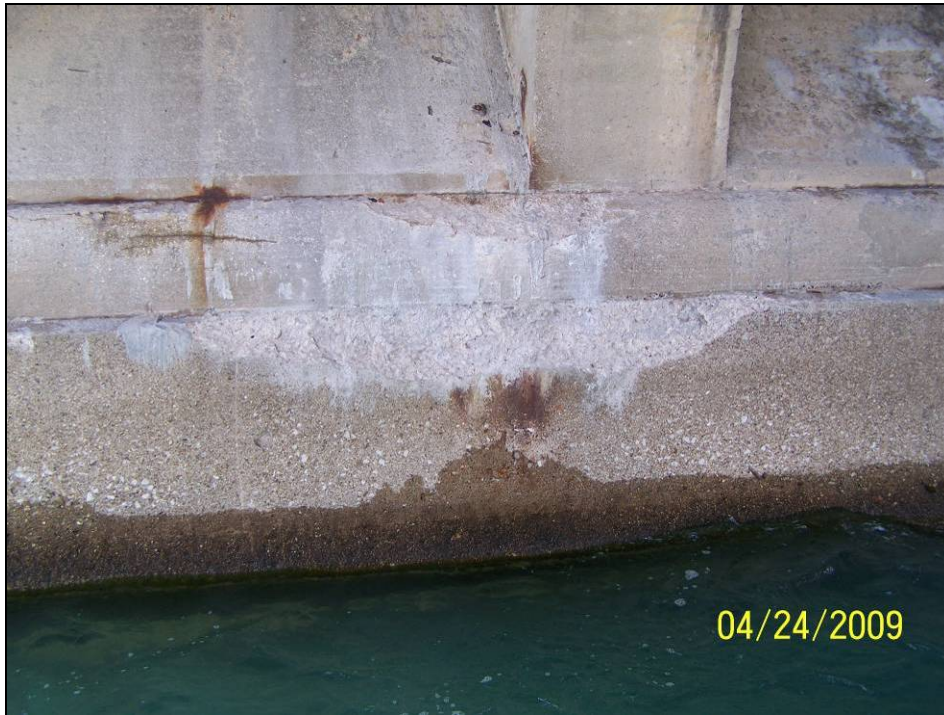
Photograph 97: View of Pier 10 Section Loss on North Face.

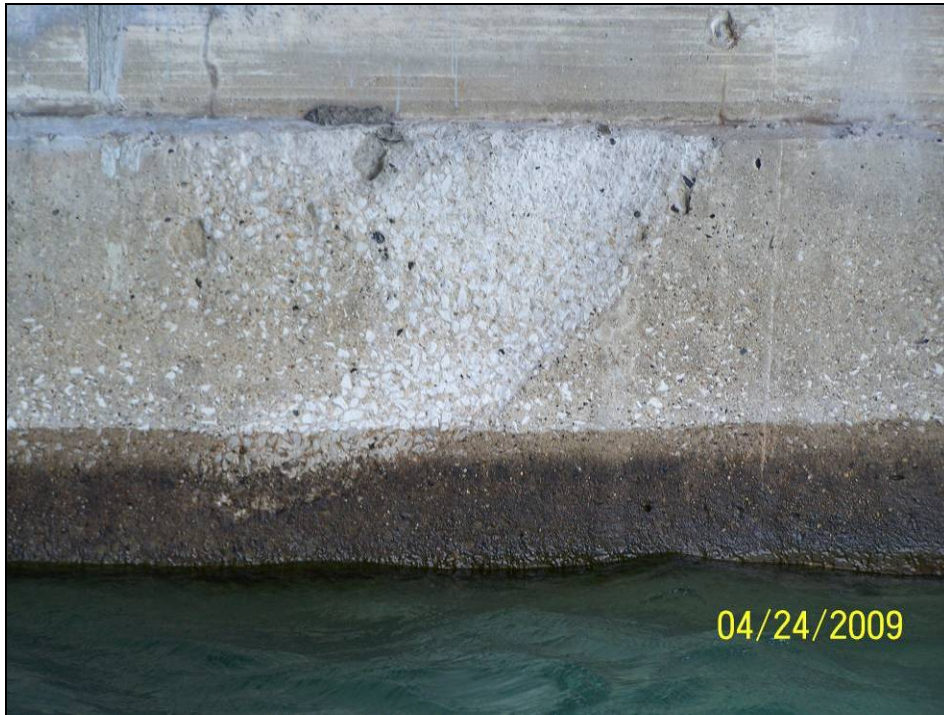
Photograph 101: View of Pier 12 Abrasion Damage on South Face.

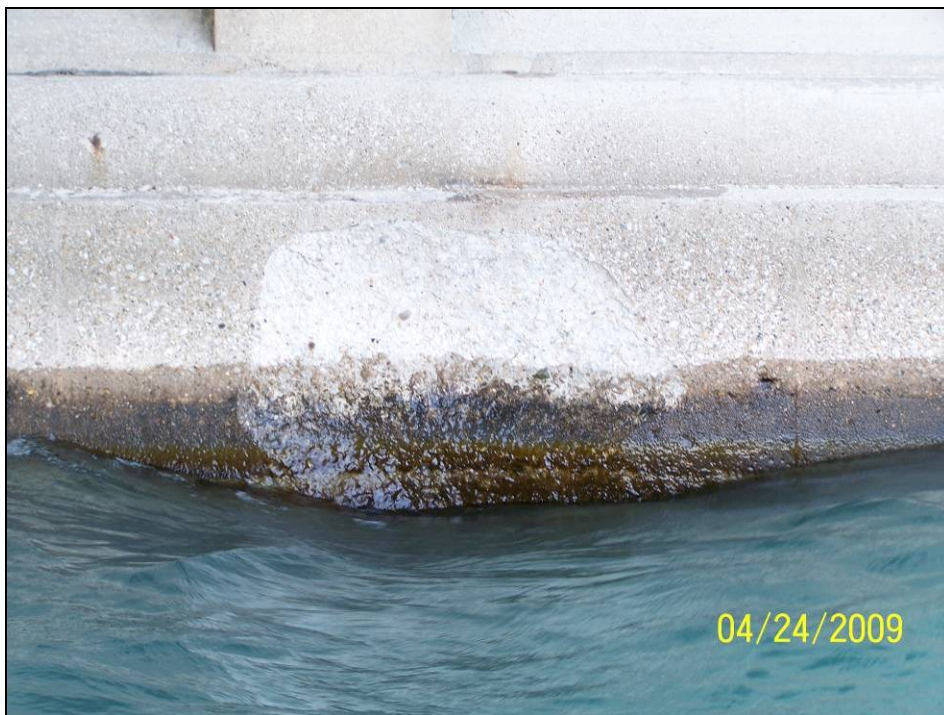
Photograph 102: View of Pier 13 Section Loss on North Face.

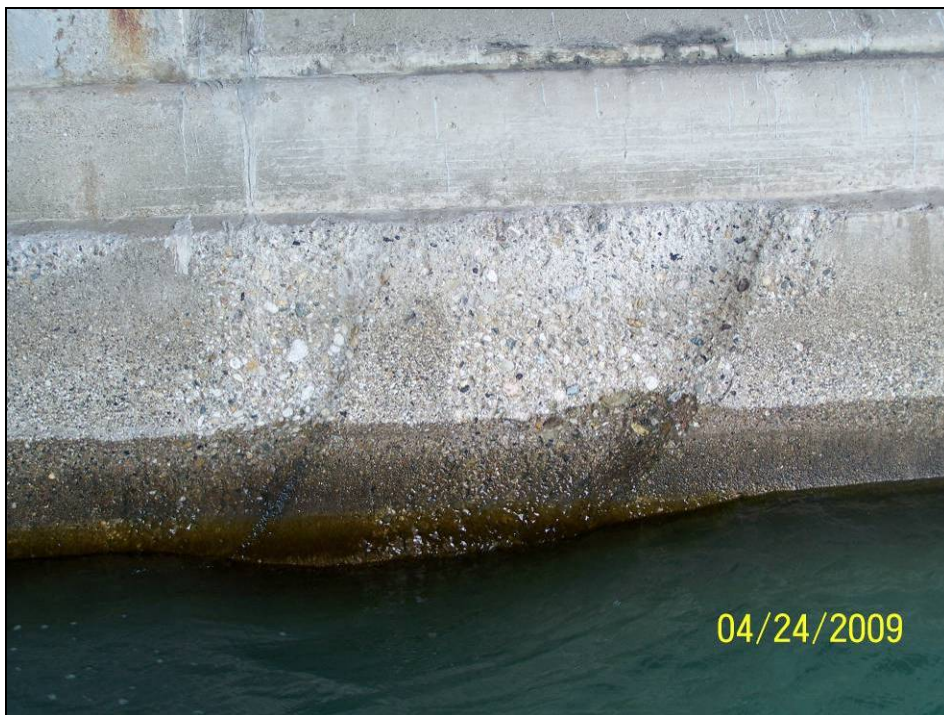
Photograph 104: View of Pier 16 Abrasion Damage on South Face.

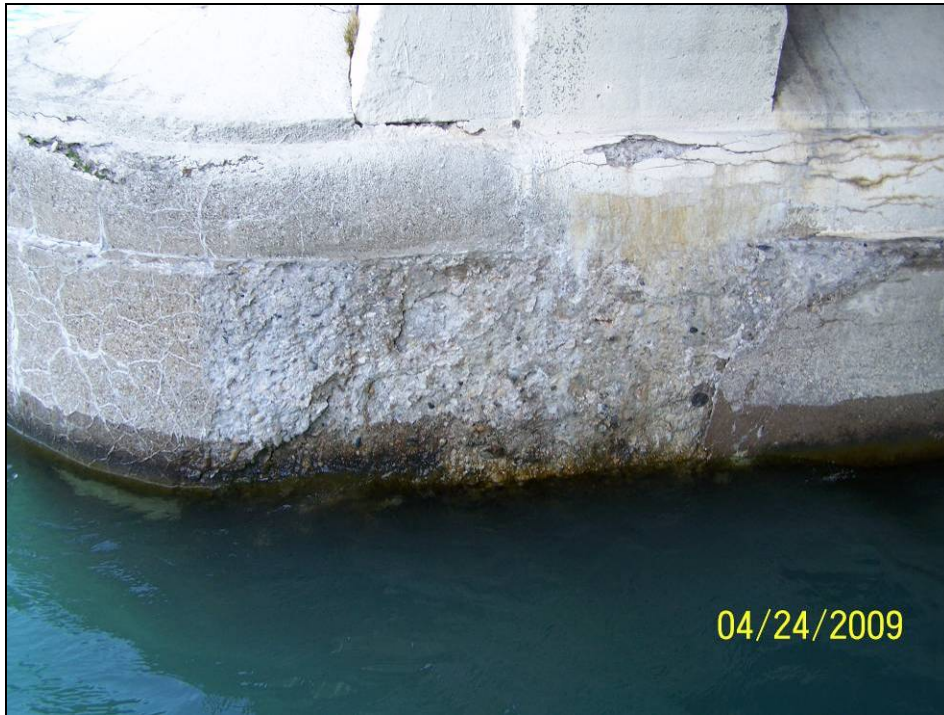
Photograph 105: View of Pier 17 Section Loss on South Face.

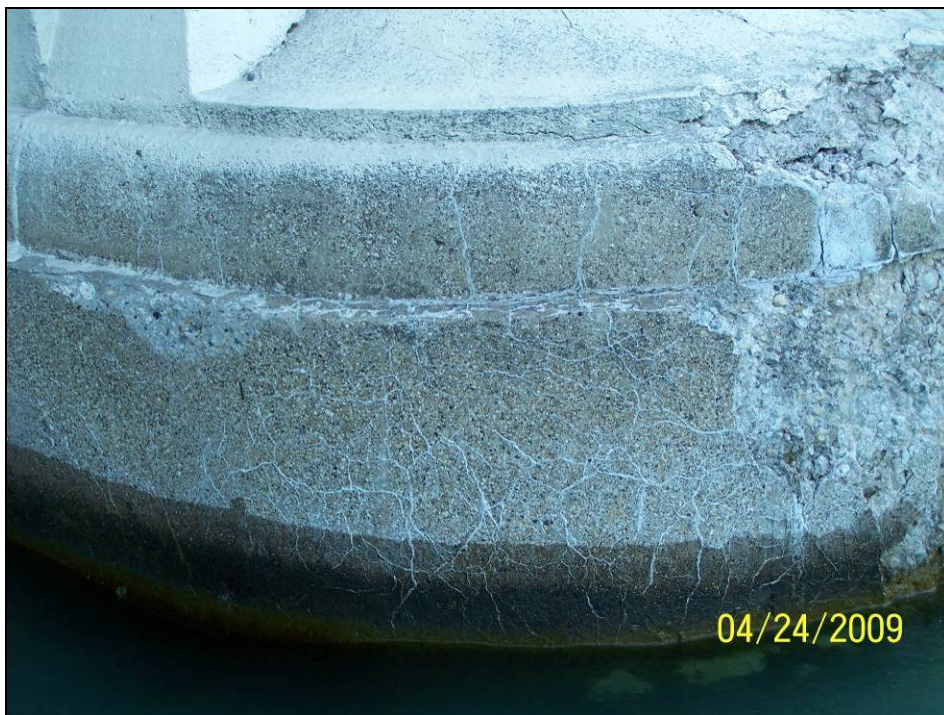
Photograph 106: View of Pier 17 Map Cracking on Downstream Nose.

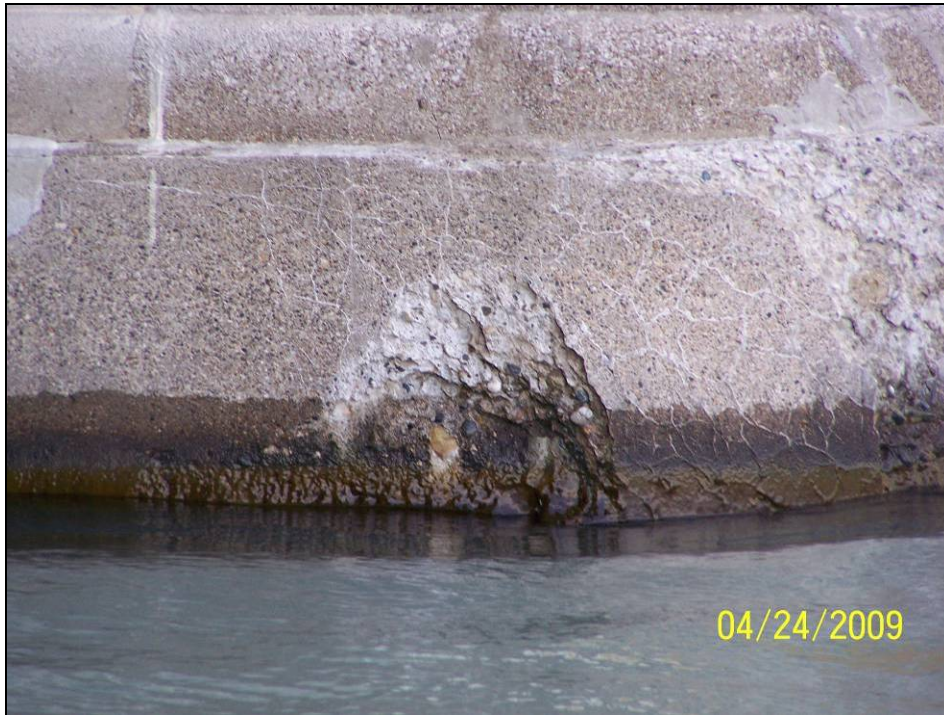
Photograph 107: View of Pier 18 Section Loss on North Face.
