Re: Sidewalk Repair Review
Claridge
1514 Washington Blvd
Detroit, MI

1514 WASHINGTON BLVD
DETROIT, MI

SHEET TITLE
PROPOSED BASEMENT SIDEWALK REPAIR
DETAIL

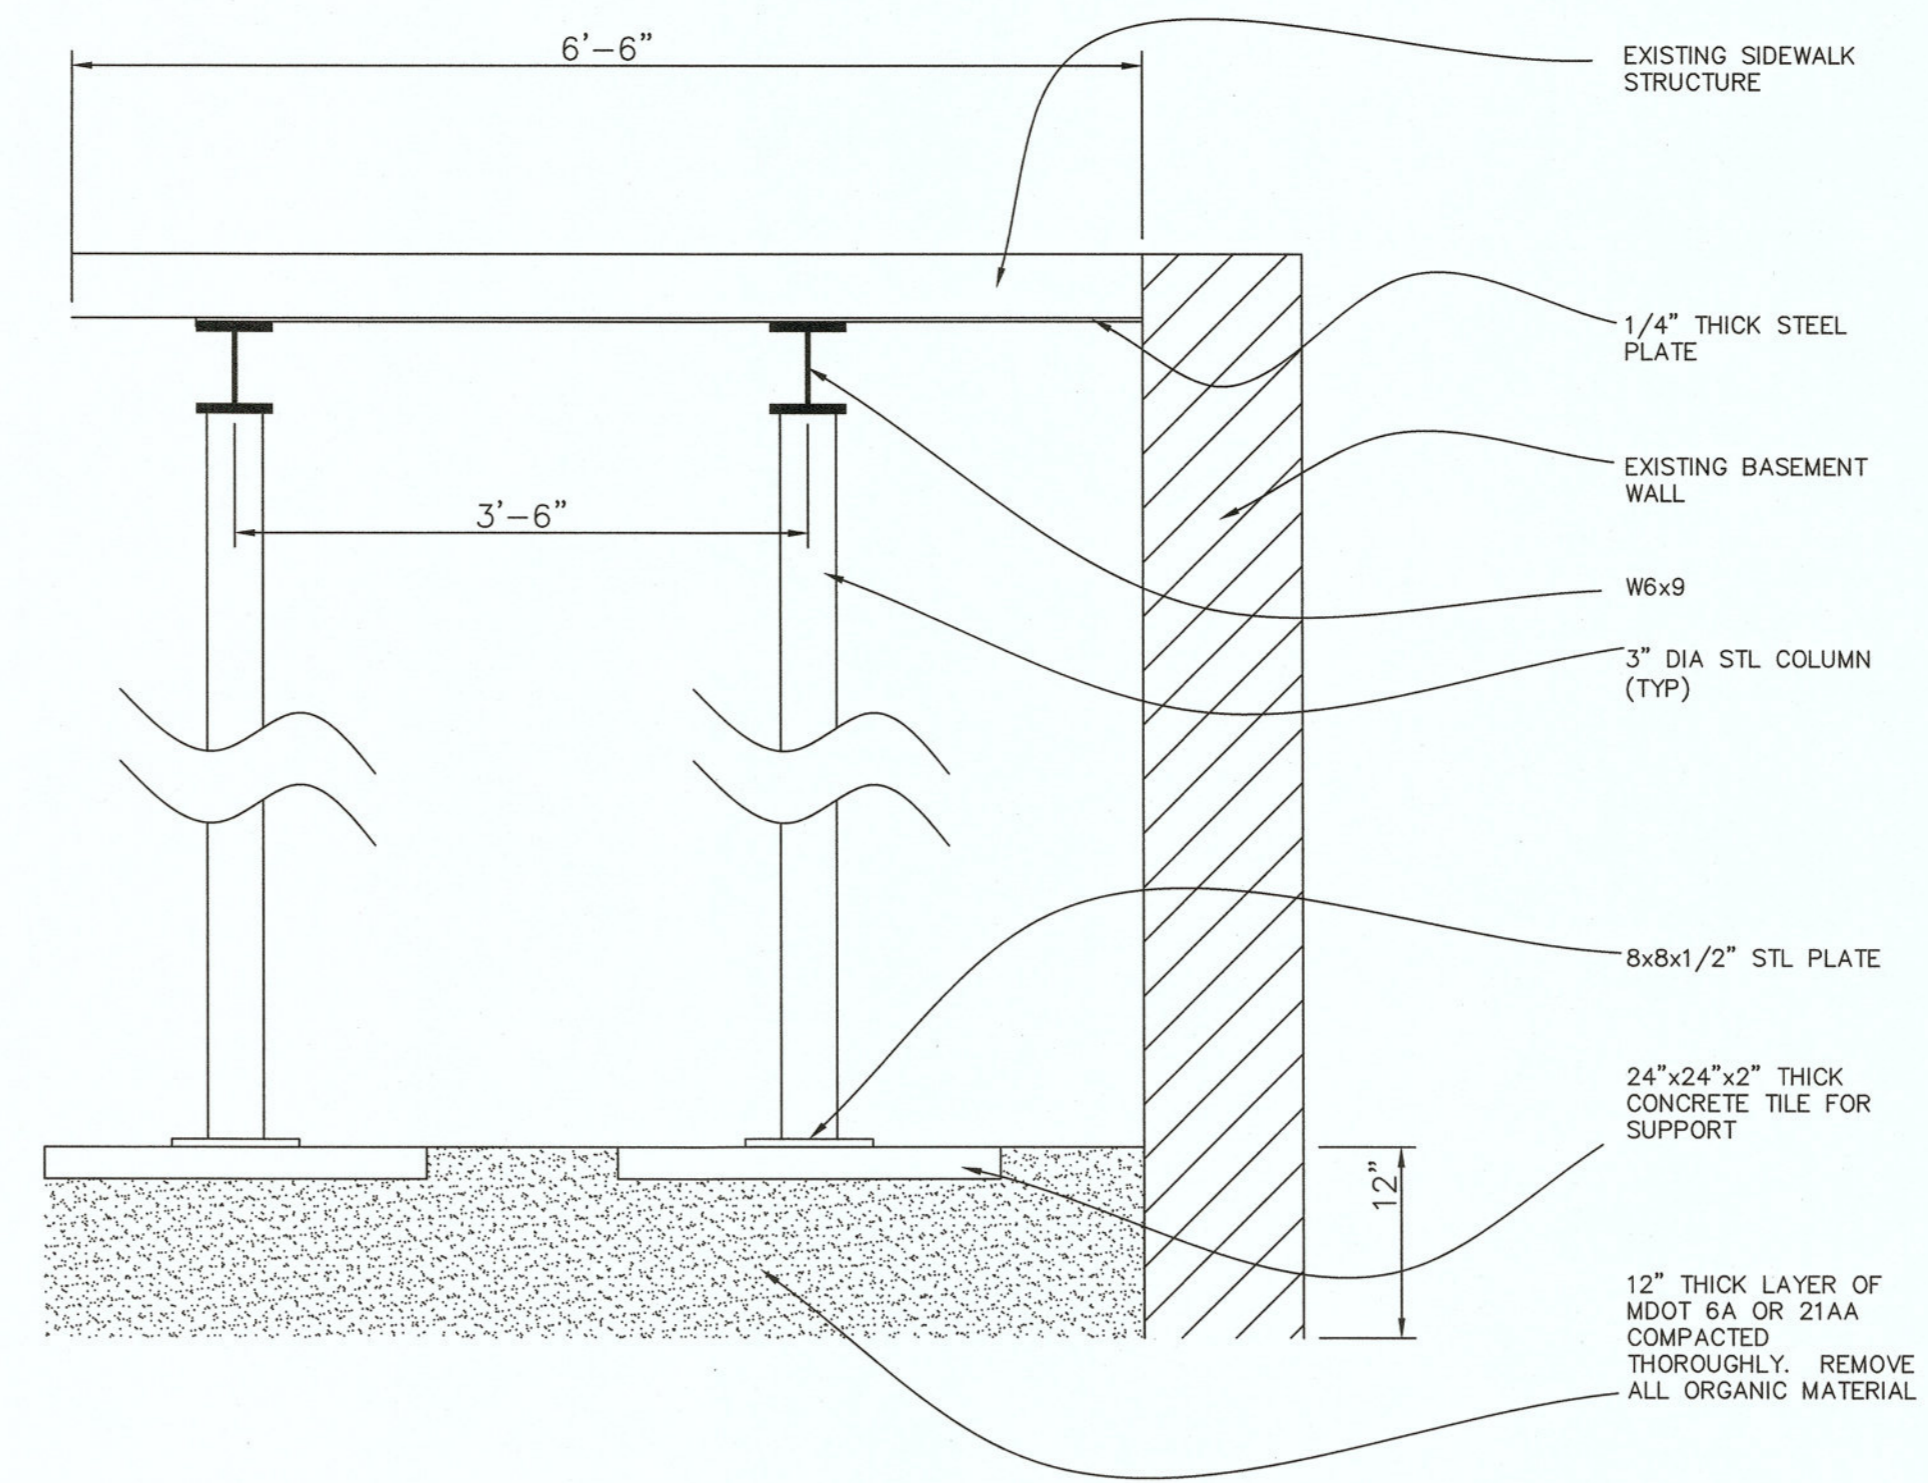
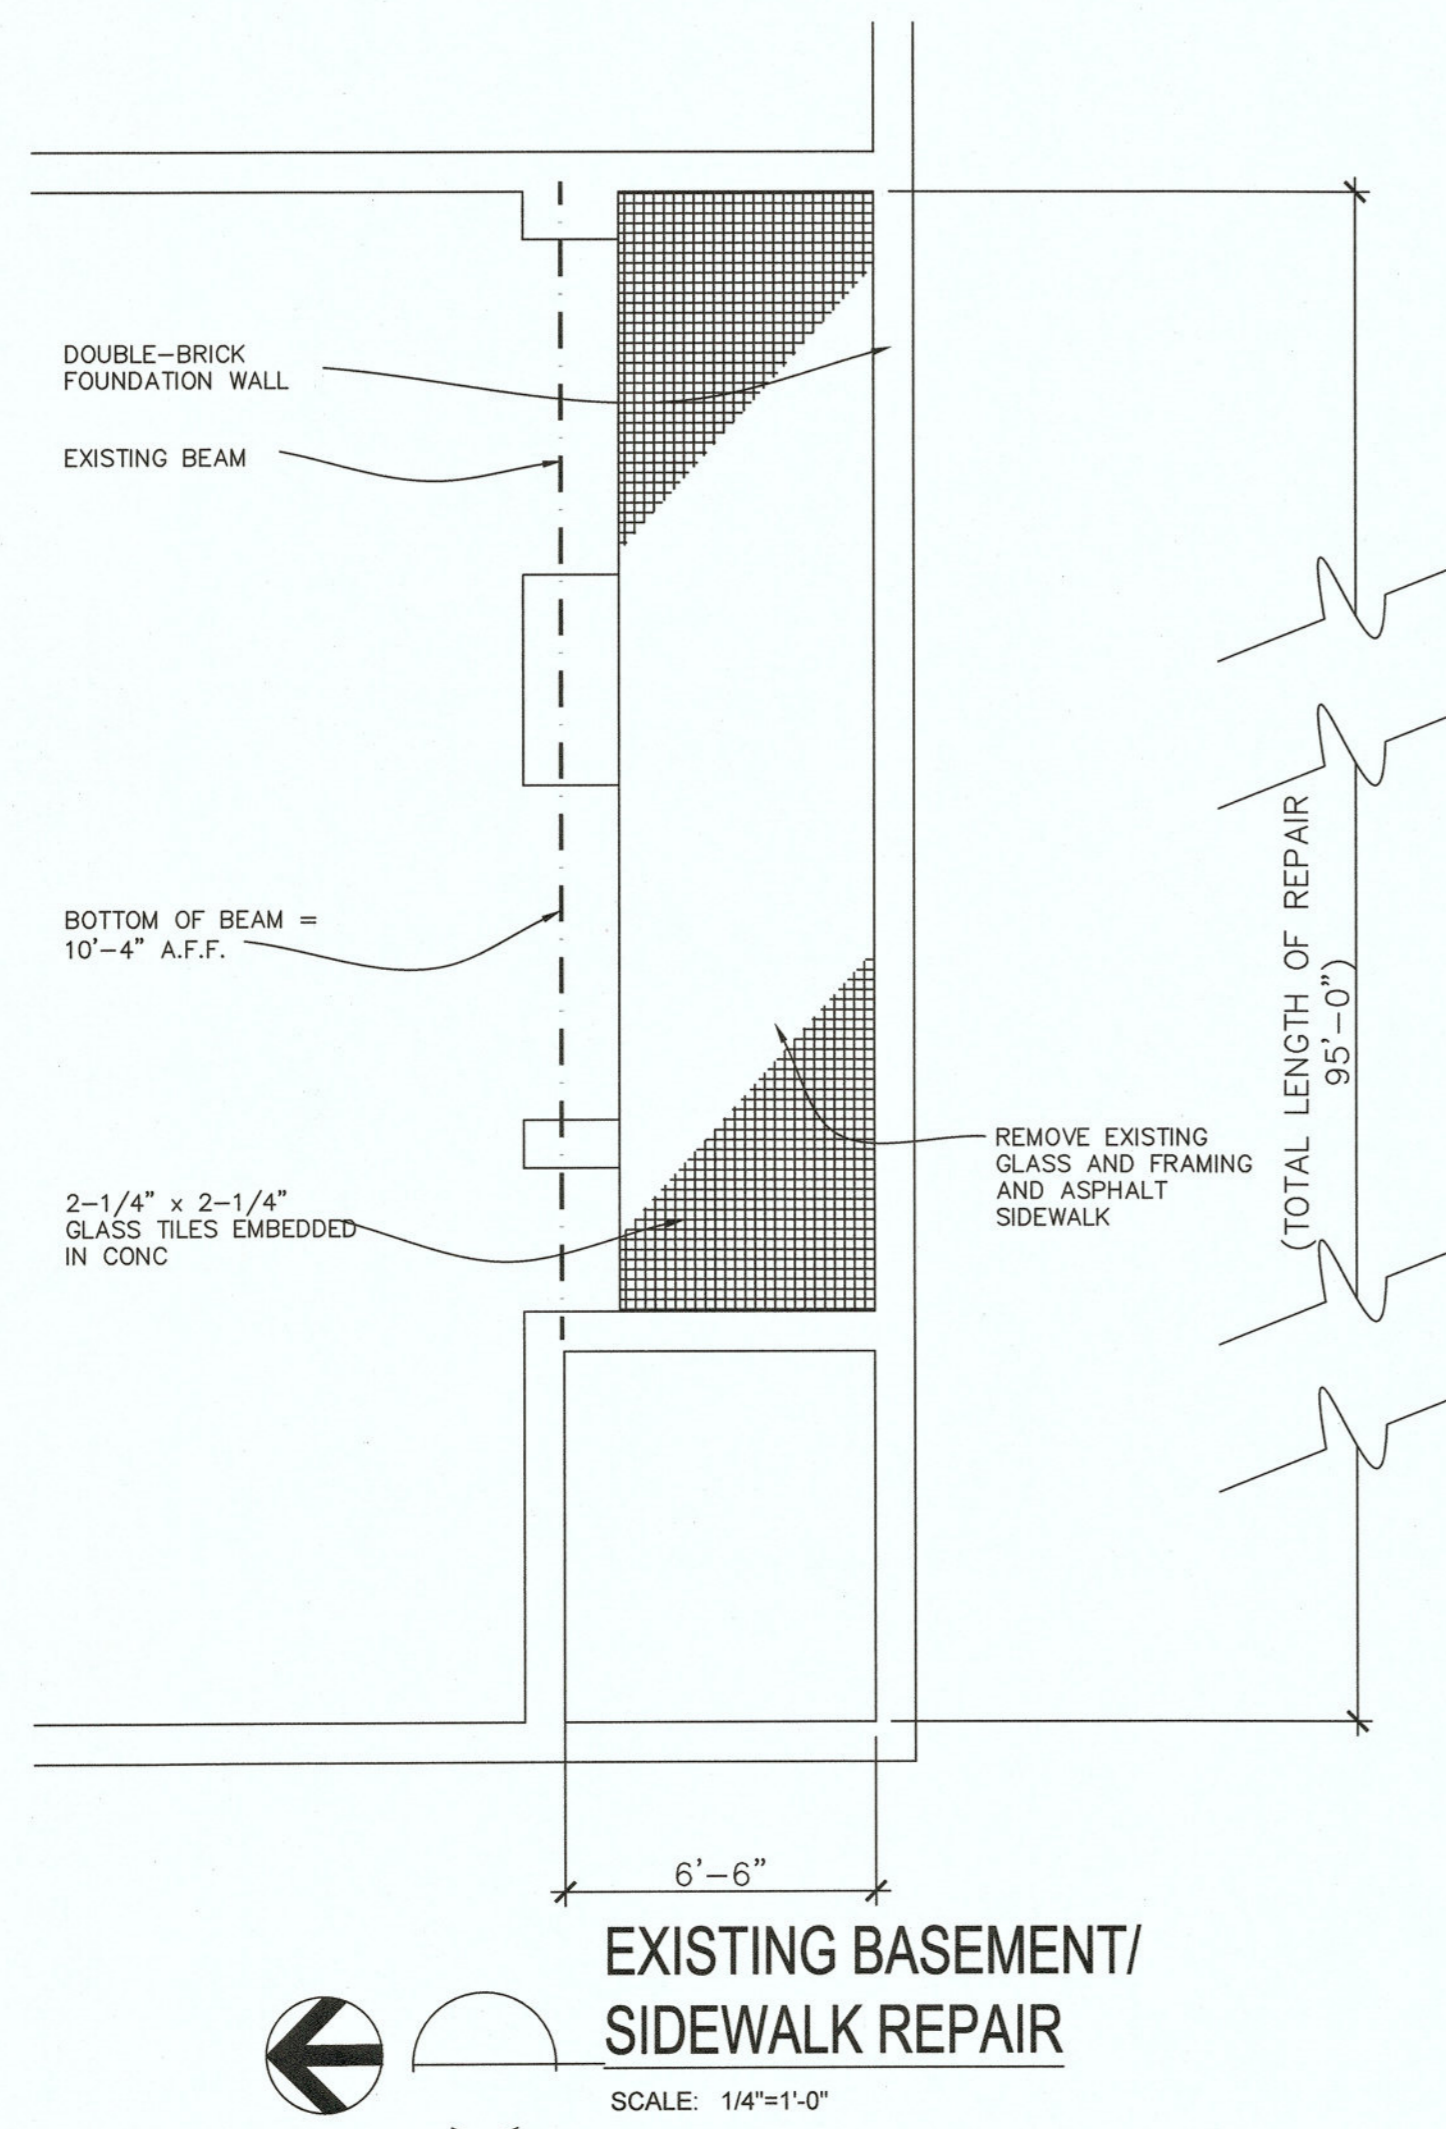
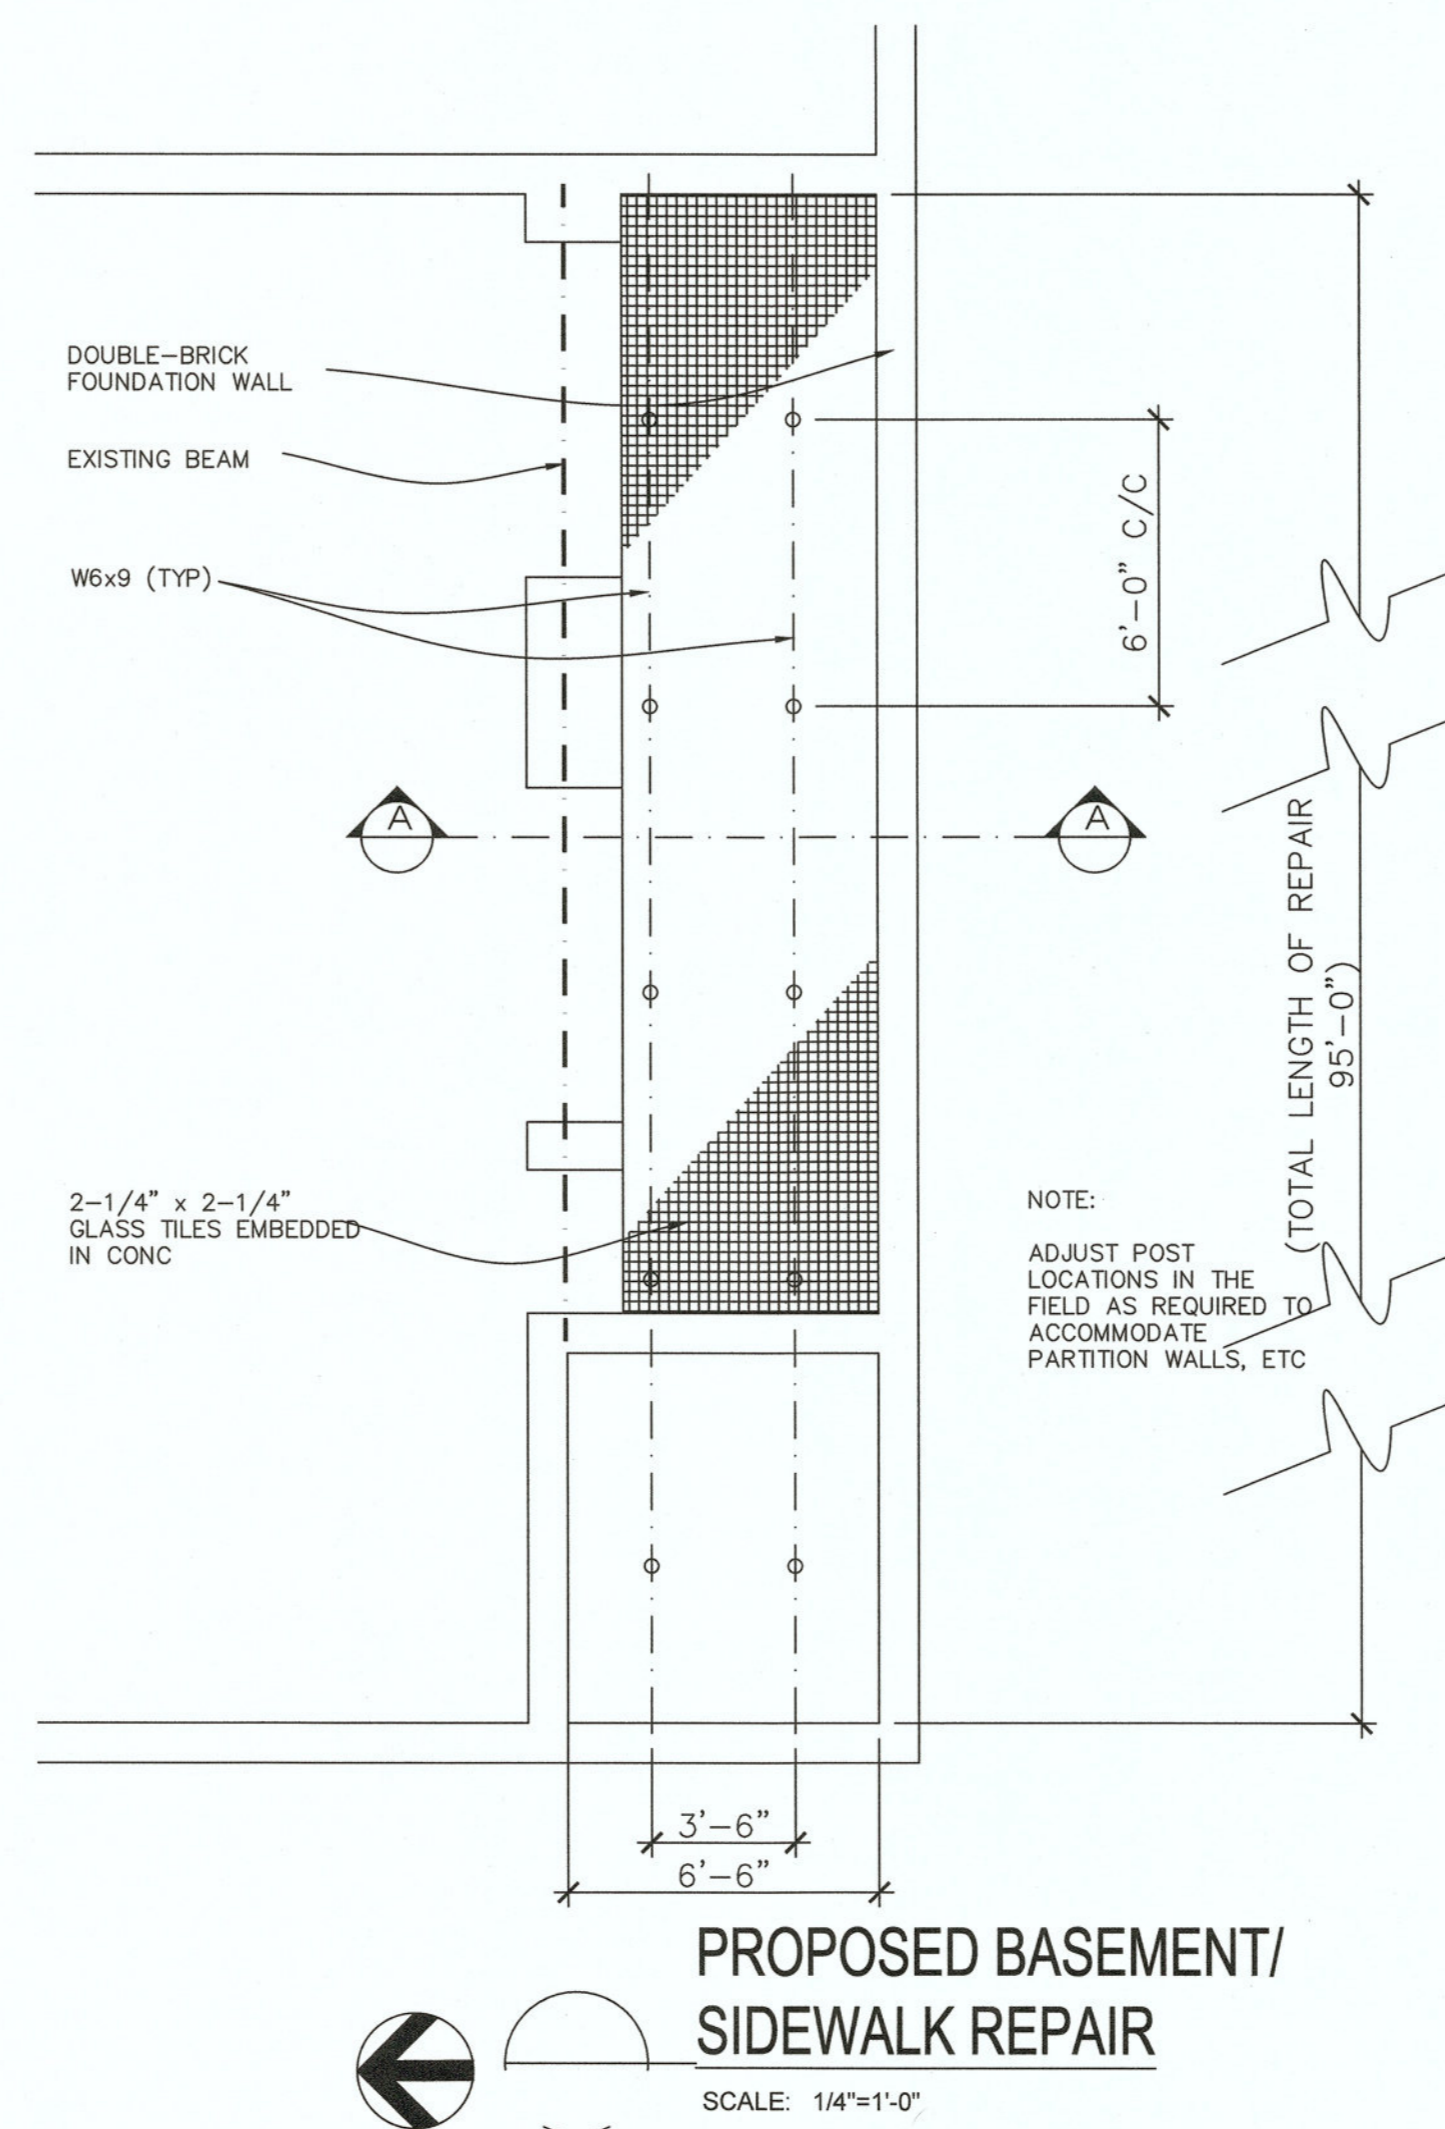
TYPICAL CROSS SECTION OF SIDEWALK DECK
SCALE: 1"=1'-0"

In 2019 we had prepared a plan to support the sidewalk framing from underside as additional support system (to the original framing system). Attached are calculation of r the steel beam and support columns. The columns are supported or either existing concrete platform for utilities and/or floor slab of the building. The maximum spacing of the posts is 8 feet and carry partial load from the sidewalk. The system was installed in 2019 with steel plate and beams and columns per plan.

Based on current field condition review, the column bases are in same condition and adequate for the purpose as it installed. The beams were designed to carry full concrete sidewalk load. Since the original framing is integral to the building foundation and to exterior wall along the sidewalk, it is planned to leave in place, clean up the damaged areas, recap the damaged asphalt with concrete. Based on the field conditions observed and our calculations, it is our opinion that current plan for sidewalk recap is adequate with leaving support system in place.
