Underwater Bridge Inspection Report

Douglas MacArthur Bridge

Over the Detroit River

April 22, 2009

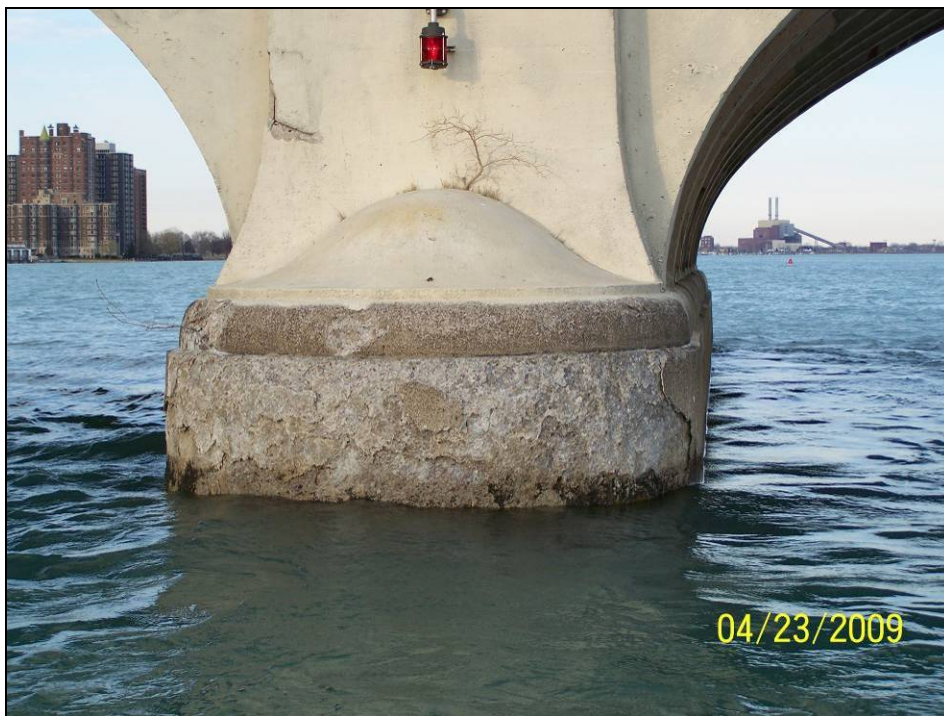
Photograph 22. View of Pier 4 Downstream Nose.

loss. The downstream nose exhibited a 15 foot wide area of section loss from 6 inches below the waterline to 3 feet above the waterline, with 3 to 5 inches of probe rod penetration. Refer to Photograph 22 in Appendix B for a view of the downstream nose.

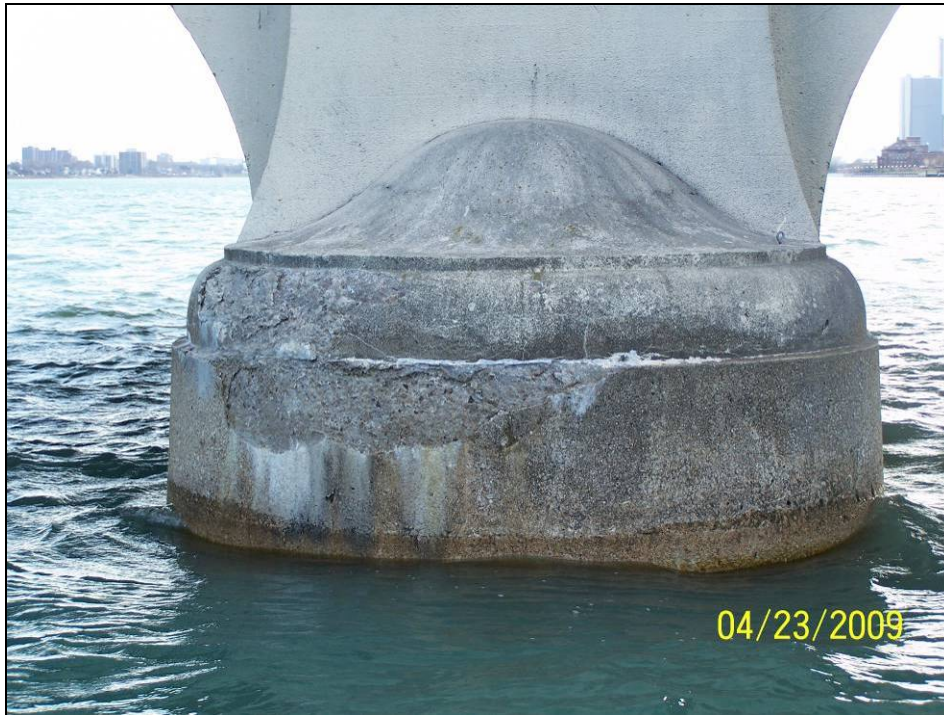
Photograph 45. View of Pier 10 Upstream Nose.

across the upstream nose, to 10 feet downstream of the southeast corner. The upstream nose had section loss over the south half from 2 feet to 4.5 feet above the waterline with 1 to 2 inches of penetration. Refer to Photograph 45 in Appendix B for a view of the upstream nose. A 5 foot long by 1 foot high area of section loss was noted 15 feet downstream of the northeast corner at 2.5 feet above the waterline. Penetrations were between 2 and 3 inches. Refer to Photograph 97 in Appendix B for a view of the section loss. The downstream nose had hairline to 1/8 inch wide map cracking with efflorescence from the waterline to 4.5 feet above the waterline. Refer to Photograph 46 in Appendix B for a view of the downstream nose.

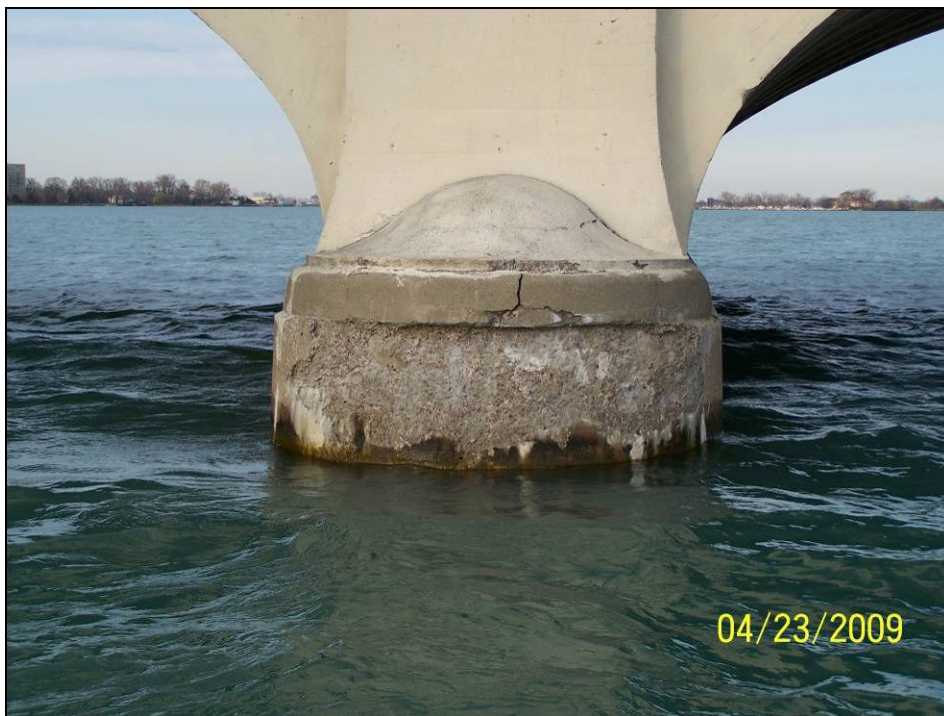
Photograph 54. View of Pier 12 Downstream Nose.

abrasion damage was located 20 feet downstream of the southeast corner, between 1 foot and 3 feet above the waterline. The area had penetrations of 1 to 2 inches. Refer to Photograph 101 in Appendix B for a view of the abrasion damage. The downstream nose exhibited section loss, concrete delaminations, and 1 inch wide cracking, extending from the waterline to 4.5 feet above the waterline. The affected area was approximately 12 feet wide and had penetrations ranging from 5 to 7 inches deep. The decorative cap at the downstream nose had 1/4 inch wide map cracking. Refer to Photograph 54 in Appendix B for a view of the downstream nose and decorative cap.

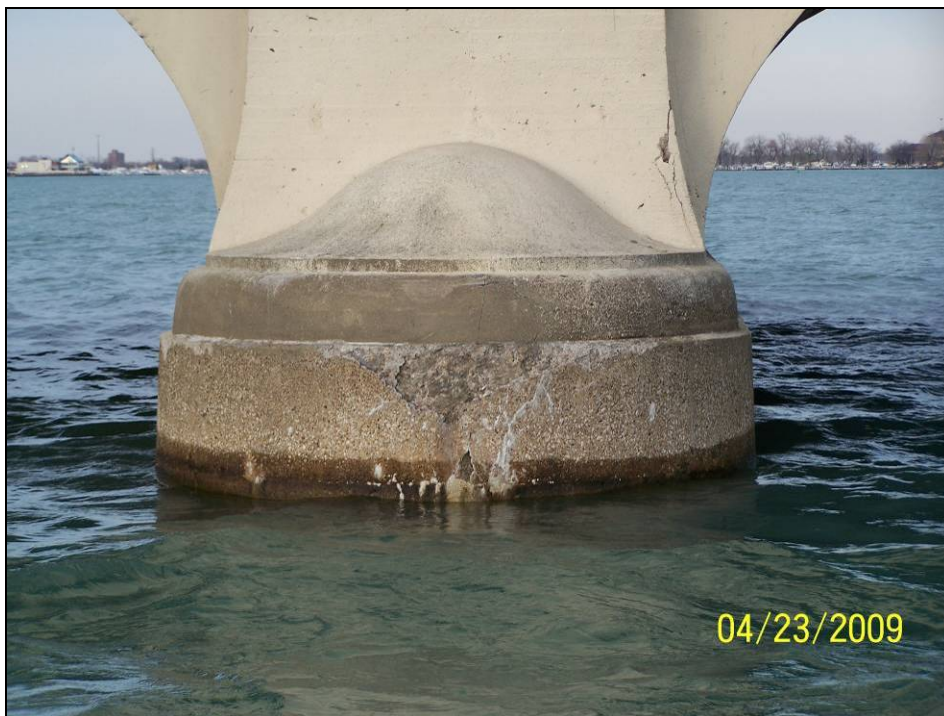
Photograph 58. View of Pier 13 Downstream Nose.

and 8 inches. Refer to Photograph 102 in Appendix B for a view of the section loss. The downstream nose had section loss and concrete delaminations for a length of 6 feet, extending from 6 inches to 4 feet above the waterline. Penetrations ranged from 2 to 4 inches. Refer to Photograph 58 in Appendix B for a view of the downstream nose.

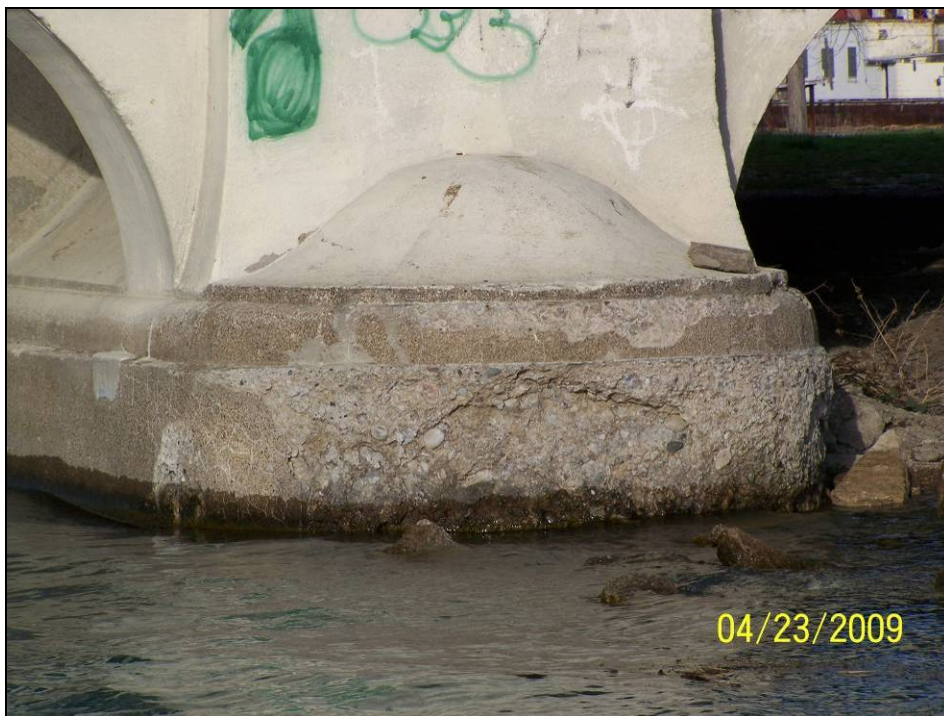
Photograph 78. View of Pier 18 Downstream Nose.

No scour or footing exposure was detected at Pier 18. At the upstream quarter point of the north face, an 8 inch diameter section of steel pipe was lying on the channel bottom. A 3 foot long area of section loss was noted on the upstream nose from 2 feet to 3 feet above the waterline, with 3 to 3 inches of penetration. Refer to Photograph 77 in Appendix B for a view of the upstream nose. A 1.5 foot long area of section loss was noted 12 feet upstream of the northwest corner from 6 inches to 12 inches above the waterline, with 3 to 4 inches of penetration. Refer to Photograph 107 in Appendix B for a view of the section loss. Heavy section loss was observed over the downstream nose

for a length of 10 to 12 feet. The section loss extended from 6 inches below the waterline to 3 feet above the waterline, with penetrations ranging from 3 to 6 inches. Areas of the downstream nose not affected by section loss exhibited hairline to 1/16 inch wide map cracking. Refer to Photograph 78 in Appendix B for a view of the downstream nose.

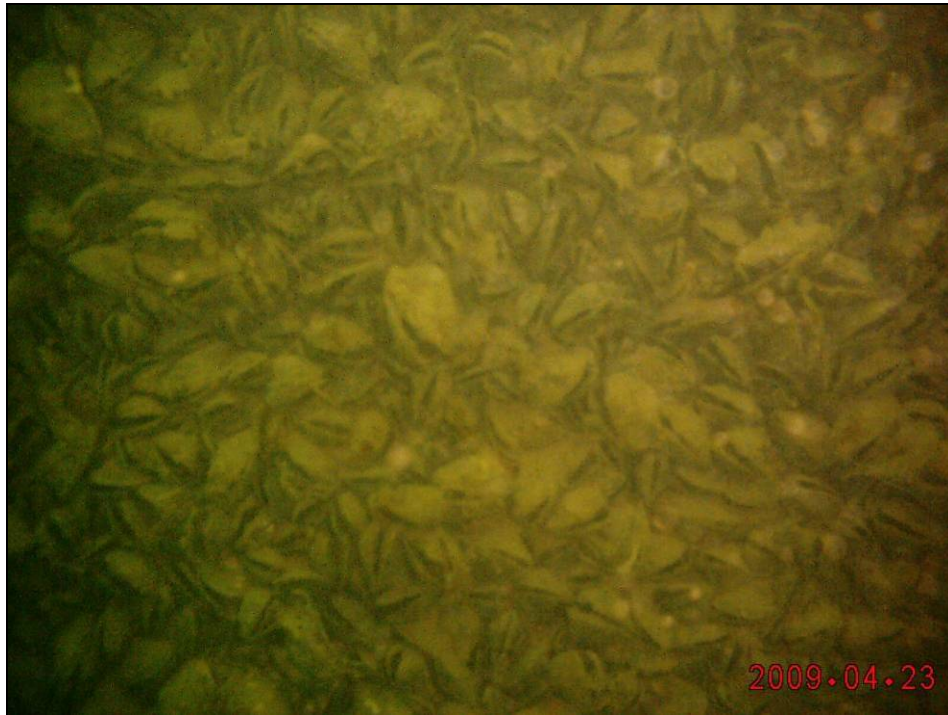
Photograph 85: View of Zebra Mussels Below the Waterline.

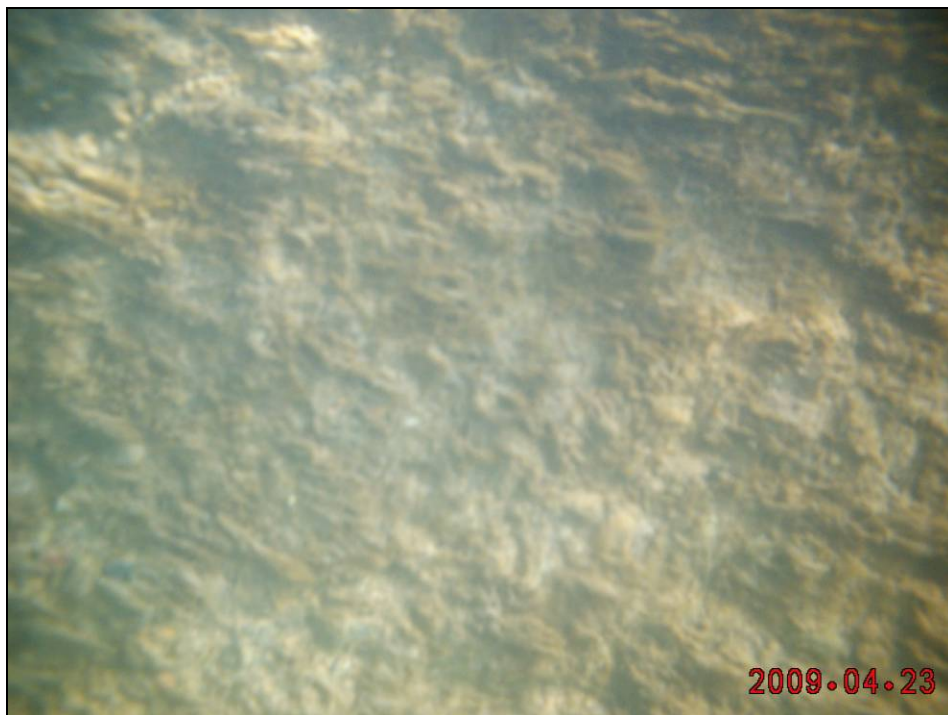
Photograph 86: View of Aquatic Growth Below the Waterline.

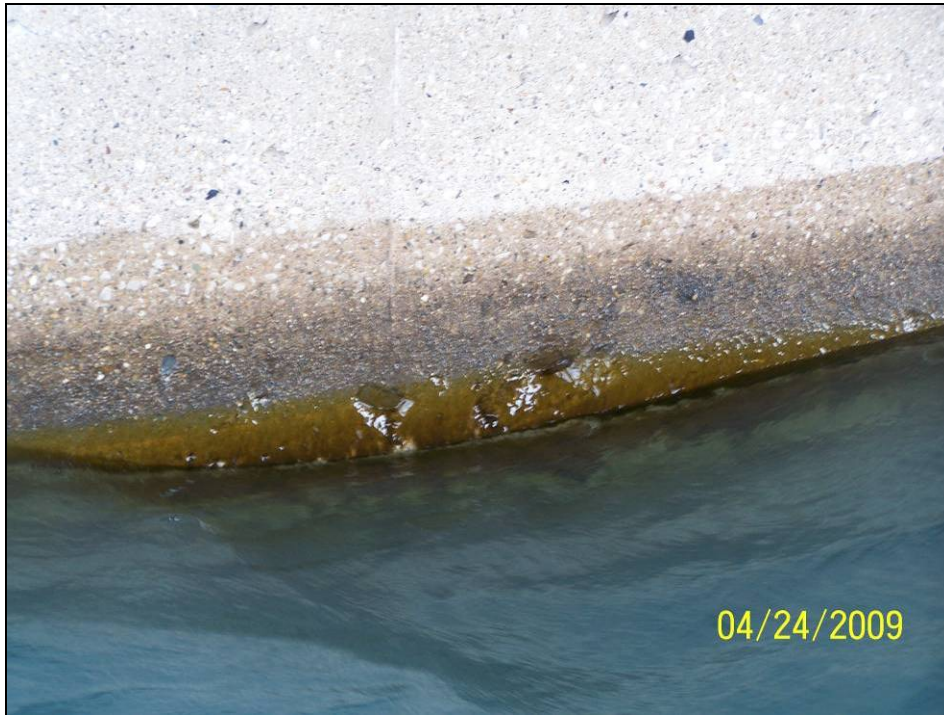
Photograph 87: View of Small Areas of Section Loss Near the Waterline.

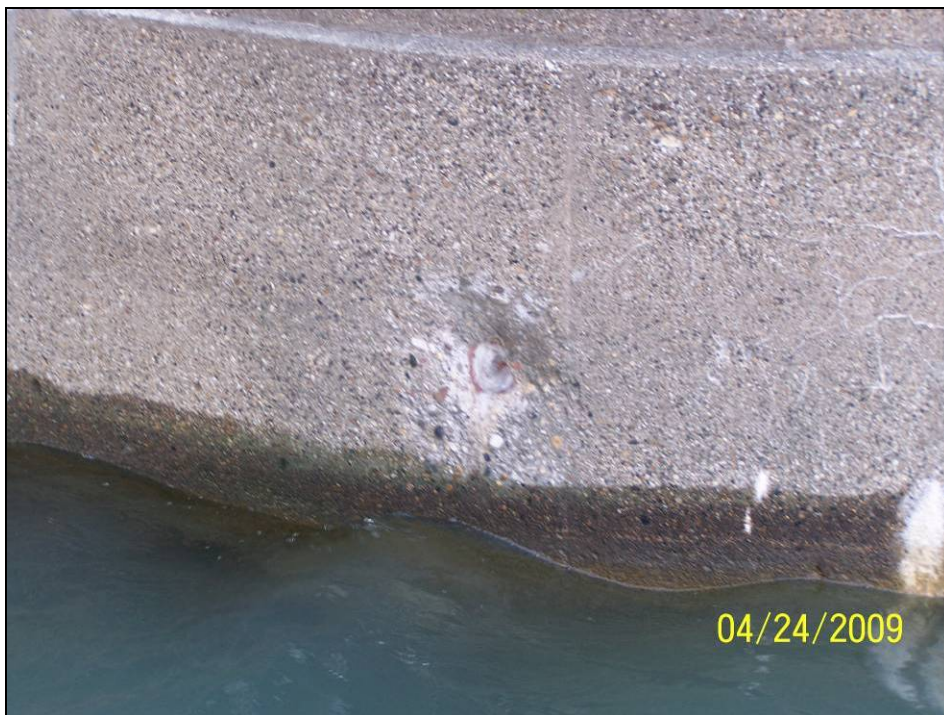
Photograph 90: View of Pier 1 Section Loss Near Northwest Corner.

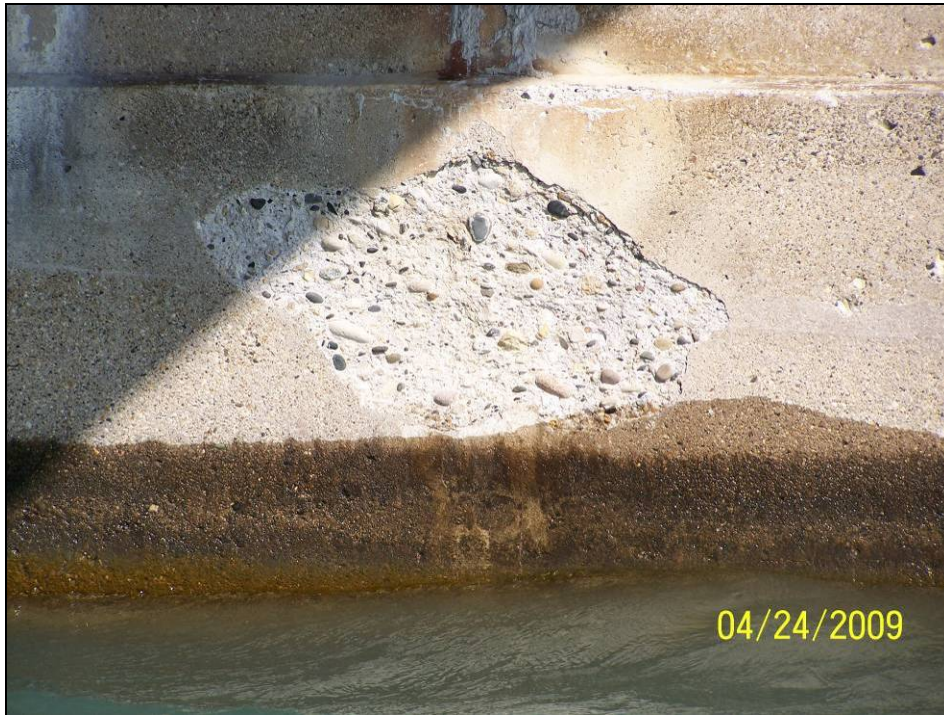
Photograph 91: View of Pier 2 Section Loss on South Face.

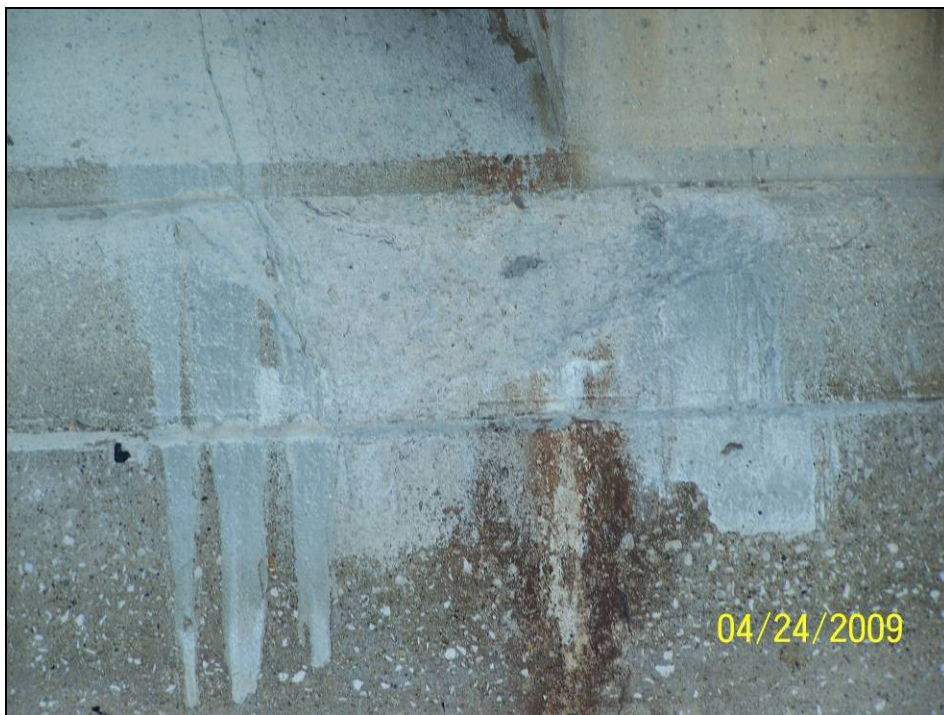
Photograph 92: View of Pier 3 Section Loss on South Face.

18. Pier 3 – An area of section loss was noted on the south face, 15 feet upstream of the southwest corner. The area was 3 feet long by 1.5 feet high with 2 to 3 inches of penetration and was centered at 3.5 feet above the waterline.

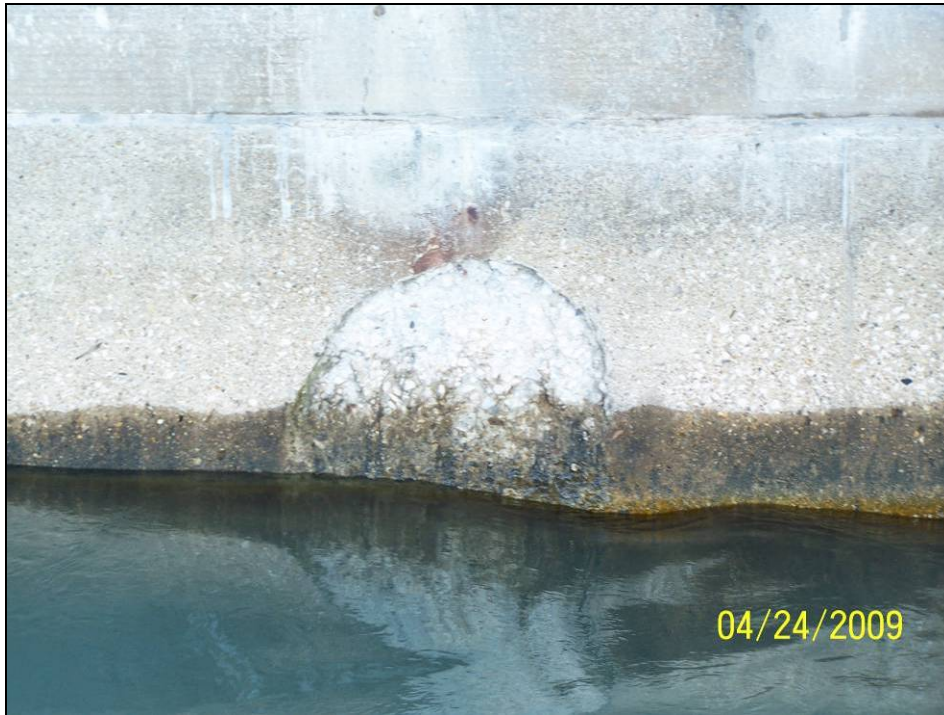
Based on depth soundings and observed footing exposure, a 4 foot to 6 foot deep scour pocket was present at the upstream nose and down the south face to the upstream quarter point. The scour pocket extended out from the nose and face approximately 8 to 12 feet. The upper tier of the footing was exposed from the center the upstream face, around the southeast corner, to the upstream quarter point on the south face. The footing was exposed vertically for 1.1 feet at the center of the upstream face and 1.5 feet at the southeast corner. No footing exposure was noted at the northeast corner or along the north face. As described in the general notes, two sets of horizontal timbers were found to protrude from the south face of the pier near the upstream end. No timbers were observed along the north face. Section loss was noted on 75 percent of the surface area of the south half of the upstream nose. The section loss extended from 1 foot above the waterline to 4.5 feet above the waterline, for a length of 8 feet. Penetrations ranged from 2 to 4 inches. Refer to Photograph 21 in Appendix B for a view of the upstream nose. Located 15 feet upstream of the southwest corner, a 3 foot diameter area of section loss was observed at 1 foot above the waterline, with 2 to 3 inches of penetration. Refer to Photograph 93 in Appendix B for a view of the section

Photograph 93: View of Pier 4 Section Loss on South Face.

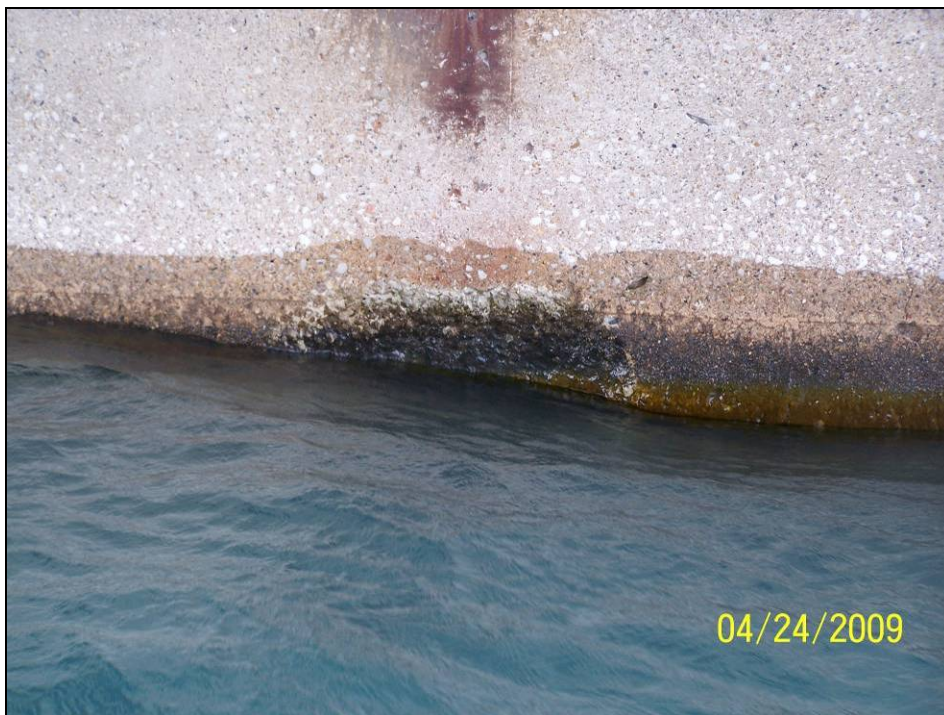
penetration. Refer to Photograph 98 in Appendix B for a view of the section loss. A similar area of section loss was noted at 15 feet upstream of the northwest corner. Refer to Photograph 99 in Appendix B for a view of the section loss. Hairline to 1/4 inch wide map cracking with efflorescence was observed over the downstream nose and decorative cap. In addition, two areas of section loss and failing concrete repairs were observed over the downstream nose between 6 and 12 inches above the waterline. The areas were between 2 and 2.5 feet in length and had penetrations ranging from 2 to 3 inches. Refer to Photograph 50 in Appendix B for a view of the downstream nose.

Photograph 98: View of Pier 11 Section Loss 15 Downstream of Northeast Corner.

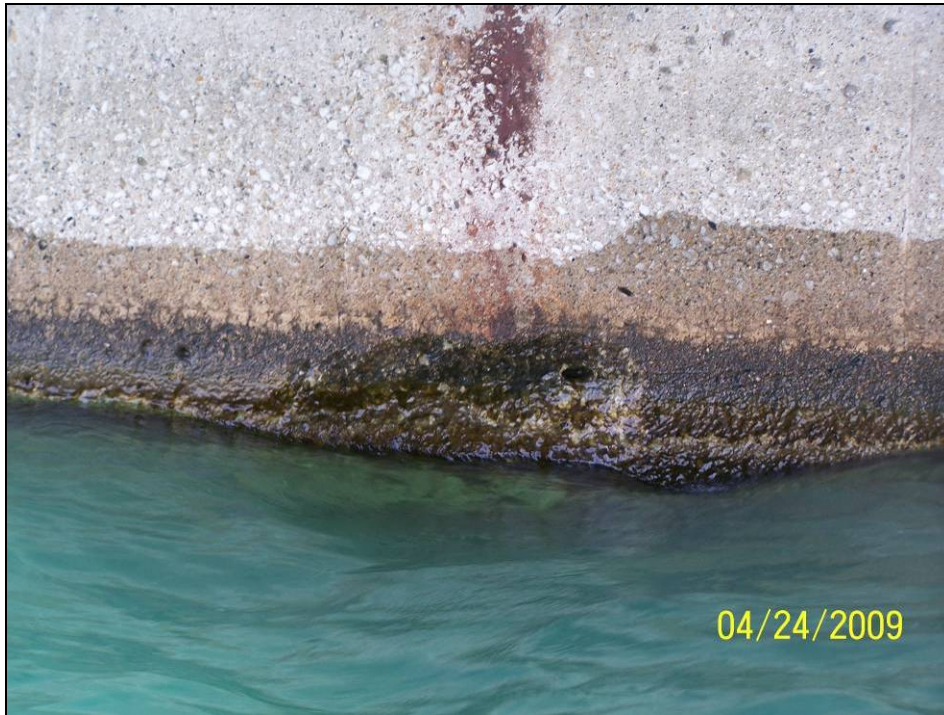
Photograph 99: View of Pier 11 Section Loss 15 Feet Upstream of Northwest Corner.

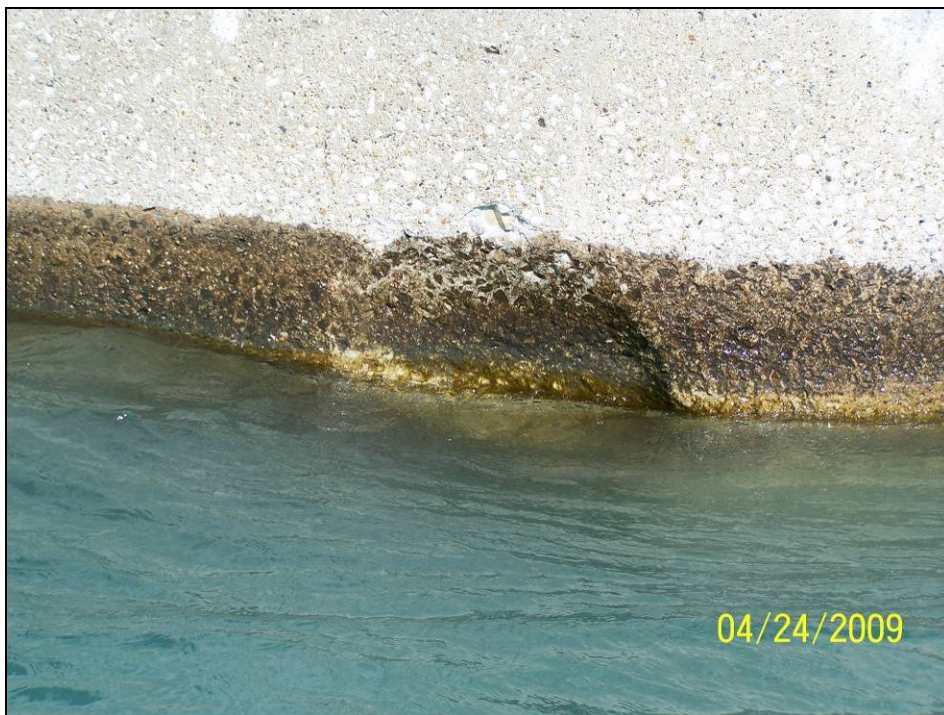
Based on depth soundings and observed footing exposure, an 8 to 10 foot deep scour pocket was present at the upstream nose which extended downstream along both faces for 10 to 15 feet. The lower tier of the footing was exposed from 10 feet downstream of the northeast corner, around and across the upstream face, to 15 feet downstream of the southeast corner. The lower tier of the footing was exposed vertically for 12 inches at the northeast corner and 8 inches at the southeast corner. The vertical exposure reached a maximum height of 2 feet at the center of the upstream face. The upper tier of the footing was exposed from 30 feet downstream of the northeast corner, around and across the upstream nose, to 45 feet downstream of the southeast corner. As described in the general notes, horizontal timbers were protruding from the faces of the pier near the channel bottom. Section loss was observed over the south half of the upstream nose from 3 feet to 4.5 feet above the waterline with 3 to 4 inches of penetration. Refer to Photograph 53 in Appendix B for a view of the upstream nose. An area of section loss measuring 3 feet long by 1 foot high was noted 12 feet downstream of the northeast corner at the waterline. The area exhibited 2 inch to 4 inch deep penetrations. A 2 foot diameter area of section loss was noted at the southeast corner of the pier, centered at the waterline. Penetrations ranged from 4 to 5 inches. Refer to Photograph 100 in Appendix B for a view of the section loss. A 2.5 foot wide area of

Photograph 100: View of Pier 12 Section Loss on North Face.

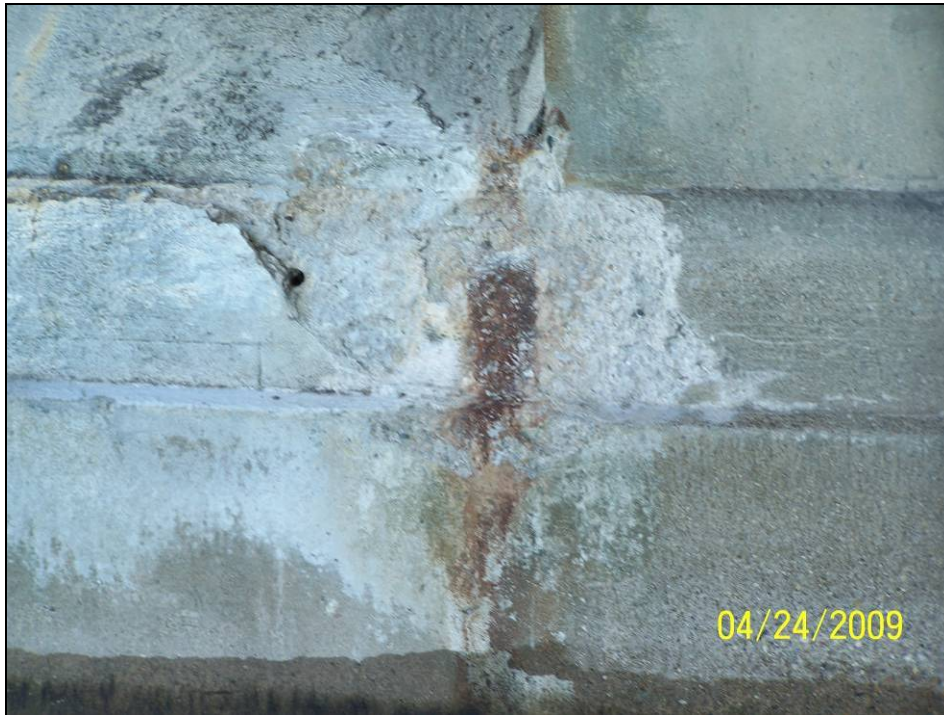
Photograph 103: View of Pier 15 Section Loss on North Face.

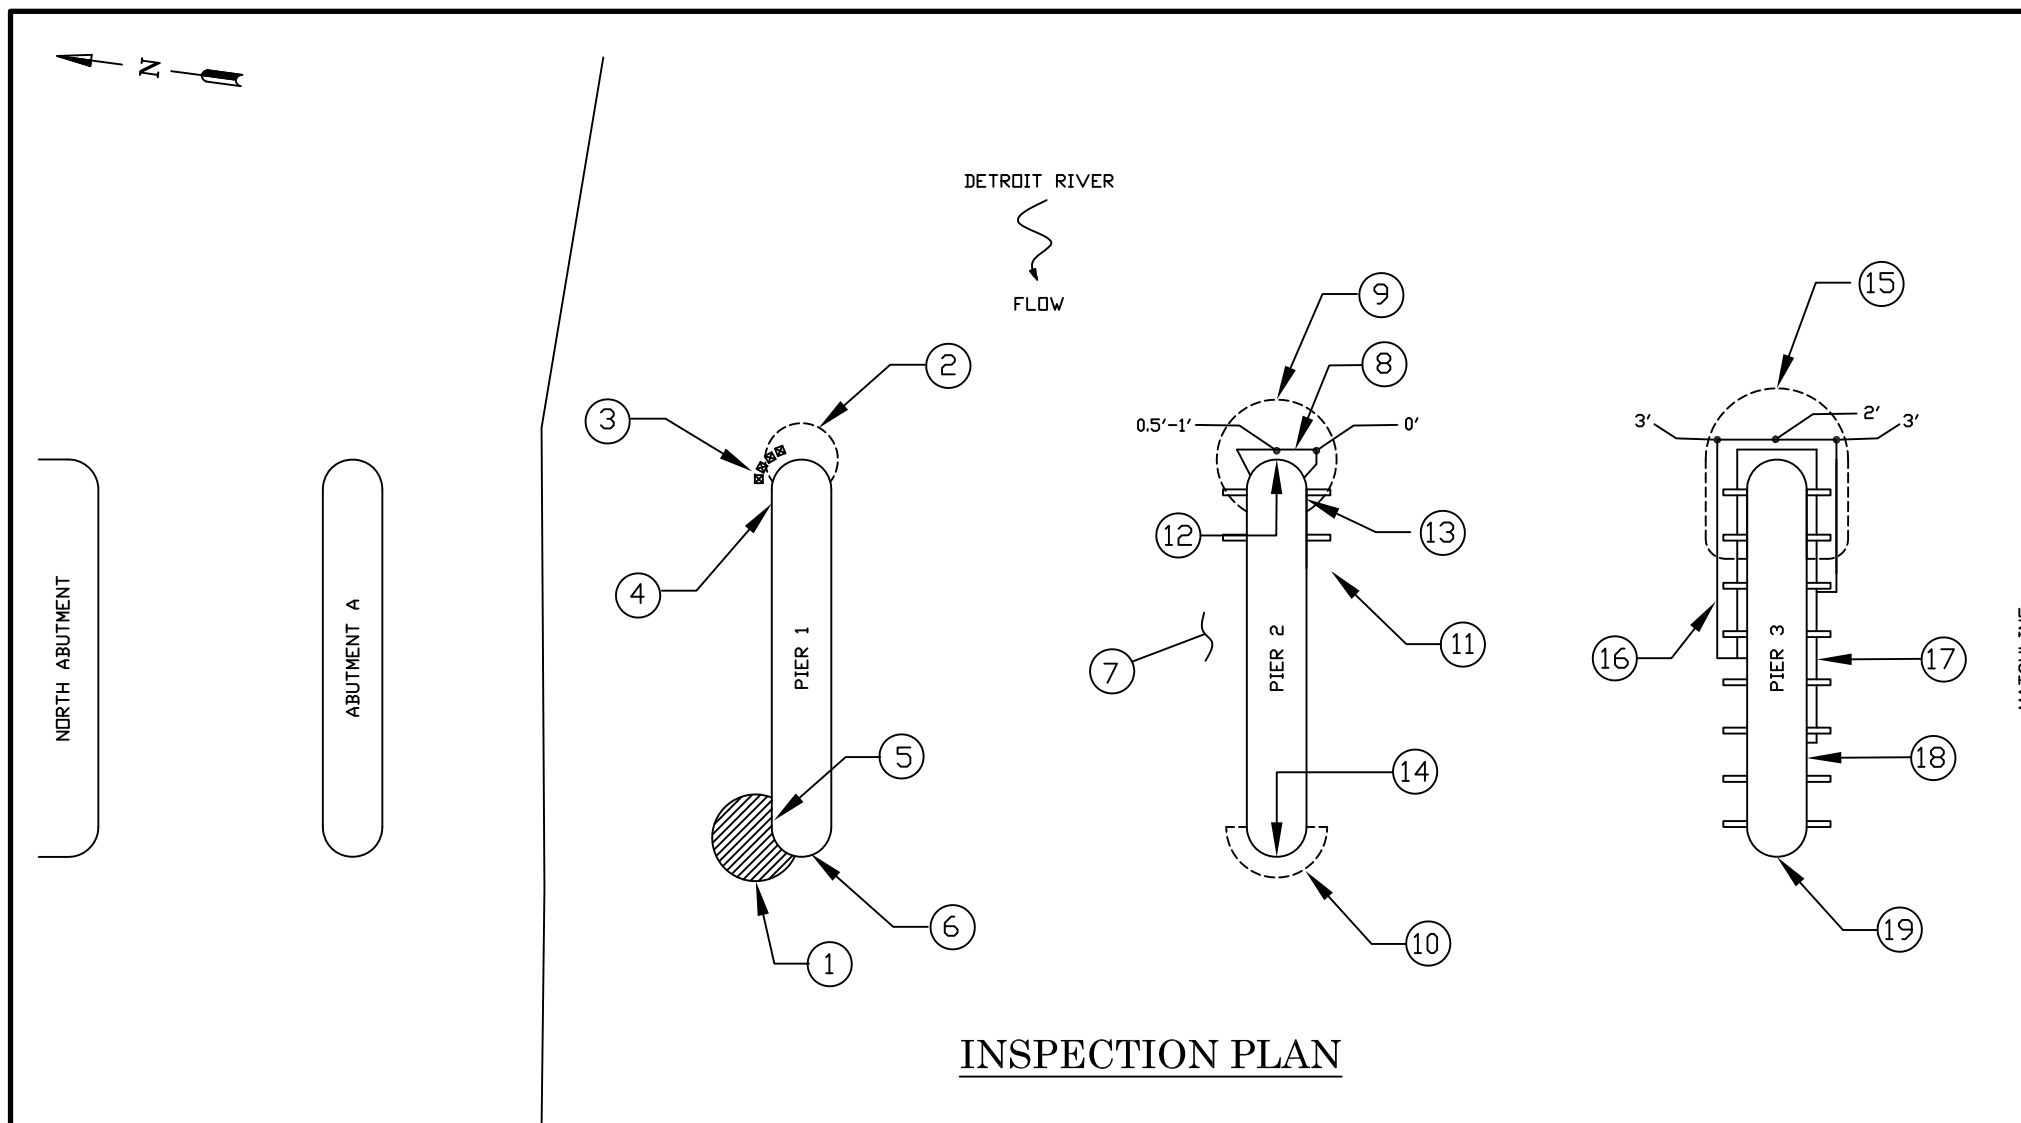
INSPECTION PLAN

12. Pier 2 – Light hairline cracking was observed over the upstream nose, most of which was horizontally oriented. The cracking extended from 1 foot to 3 feet above the waterline for a width of 6 feet. Efflorescence was present at the cracks.

14. Pier 2 – The downstream nose exhibited section loss for a width of 8 feet which extended from 1 foot to 3 feet above the waterline, with penetrations of 3 to 6 inches. In addition, hairline to 1/2 inch wide map cracking was observed over the downstream nose from 6 inches below the waterline to 6 feet above the waterline.

3. Around the entire perimeter, the concrete of the piers typically exhibited light 1/4 inch to 3/4 inch deep scaling from 6 inches to 24 inches below the waterline. Moderate scaling, 1 inch to 1-1/2 inches deep, was present over the upstream noses of the piers in the same zone. In addition, approximately 5 to 15 small areas of section loss were present on the pier faces between 1 foot below the waterline and 2 feet above the waterline. The small areas of section loss were typically 3 to 6 inches in diameter; however, 9 to 12 inch diameter areas were occasionally observed. These areas of section loss exhibited penetrations ranging from 1.5 to 3 inches in depth.

4. Square voids measuring 12 inches by 12 inches were typically observed in the north and south faces of the piers. Each face exhibited four voids approximately located at the quarter points and the third points. Penetrations of 3 feet were recorded without stoppage.

5. As noted in the previous report, horizontal timbers measuring 12 inches by 12 inches typically protruded out from the north and south faces of the piers for 4 to 6 feet. The spacing of the timbers was relatively consistent and was estimated to be approximately 10 feet. At a maximum, a total of eight timbers were observed along one face. The top of the timbers appeared to be located at a consistent depth of approximately 16 feet below the waterline. In many instances, two 12 inch by 12 inch timbers were stacked on top of each other to create a 12 inch wide by 24 inch high timber. The number of timbers exposed at each pier and the extent of their exposure varied with the channel bottom elevation. In general, more timbers were exposed at the upstream end of the piers where the channel bottom elevations were deeper. As the channel bottom depths increased towards the downstream end of the piers, the number of timbers and extent of exposure decreased.

6. Along both shorelines, concrete riprap was present and ranged in diameter from 1 to 4 feet along with concrete slabs that were 6 to 8 inches thick and up to 6 feet in diameter. Beyond the immediate shoreline, the embankments had little to no slope and were maintained grass/parkland. No erosion or embankment instability was observed.
