Re: Sidewalk Repair Review
Claridge
1514 Washington Blvd
Detroit, MI

1514 WASHINGTON BLVD
DETROIT, MI

SHEET TITLE
PROPOSED BASEMENT SIDEWALK REPAIR
DETAIL

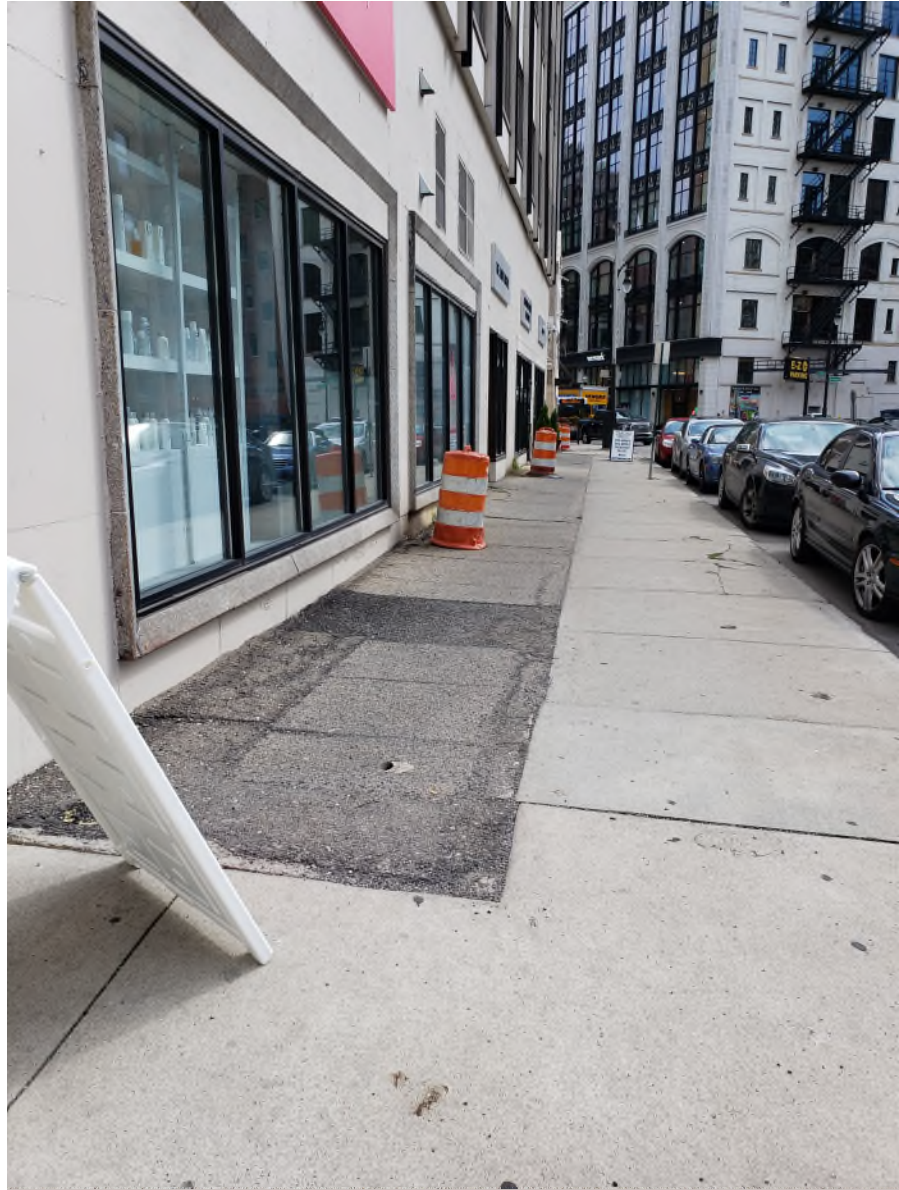
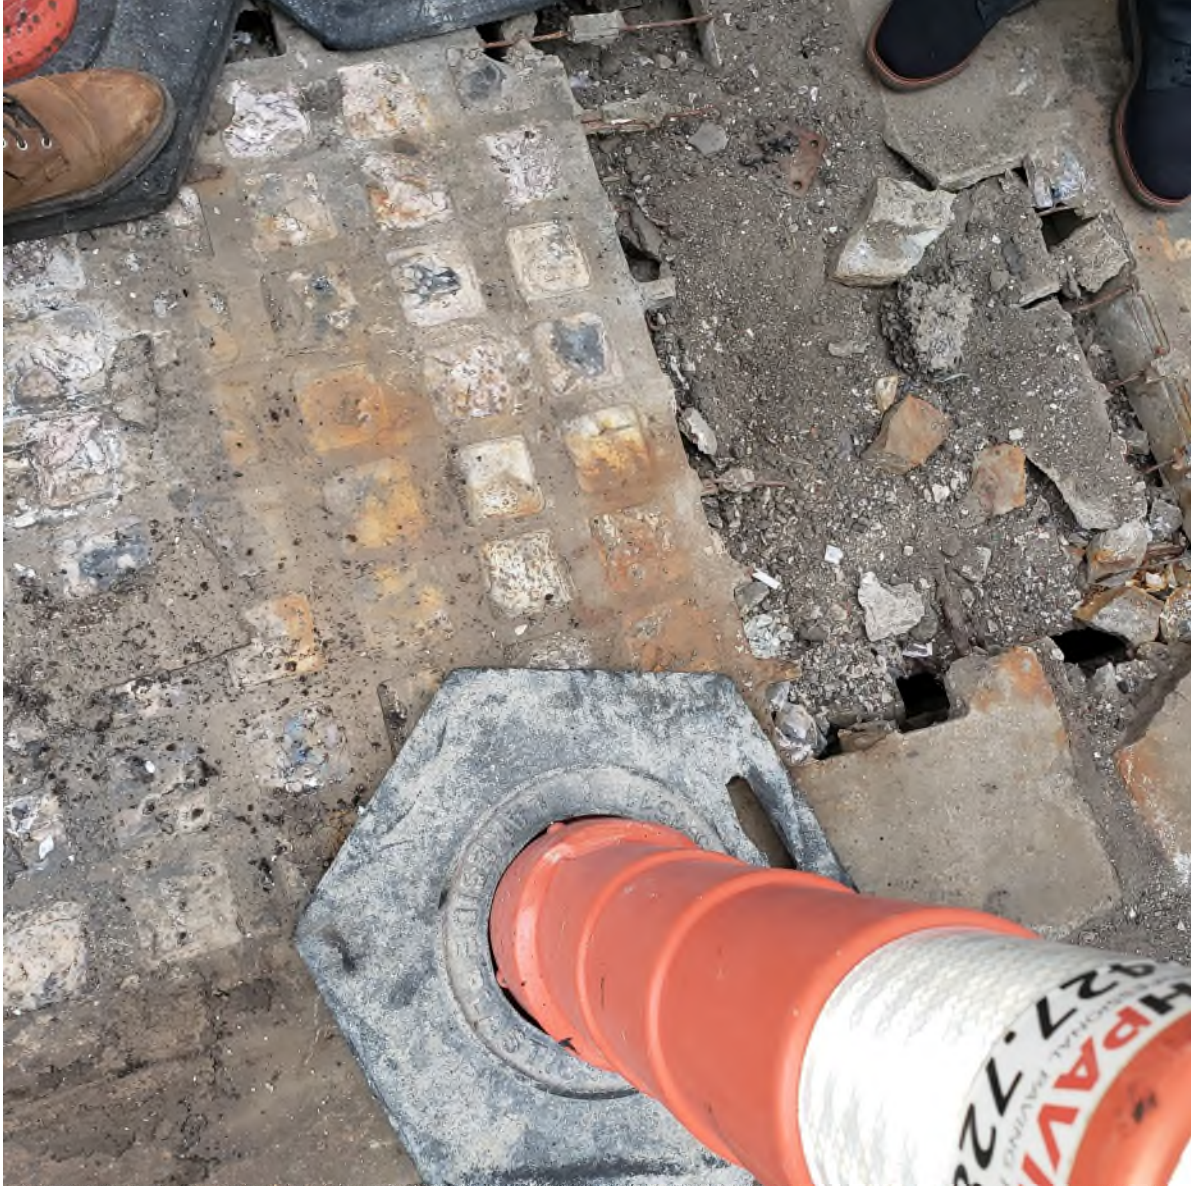
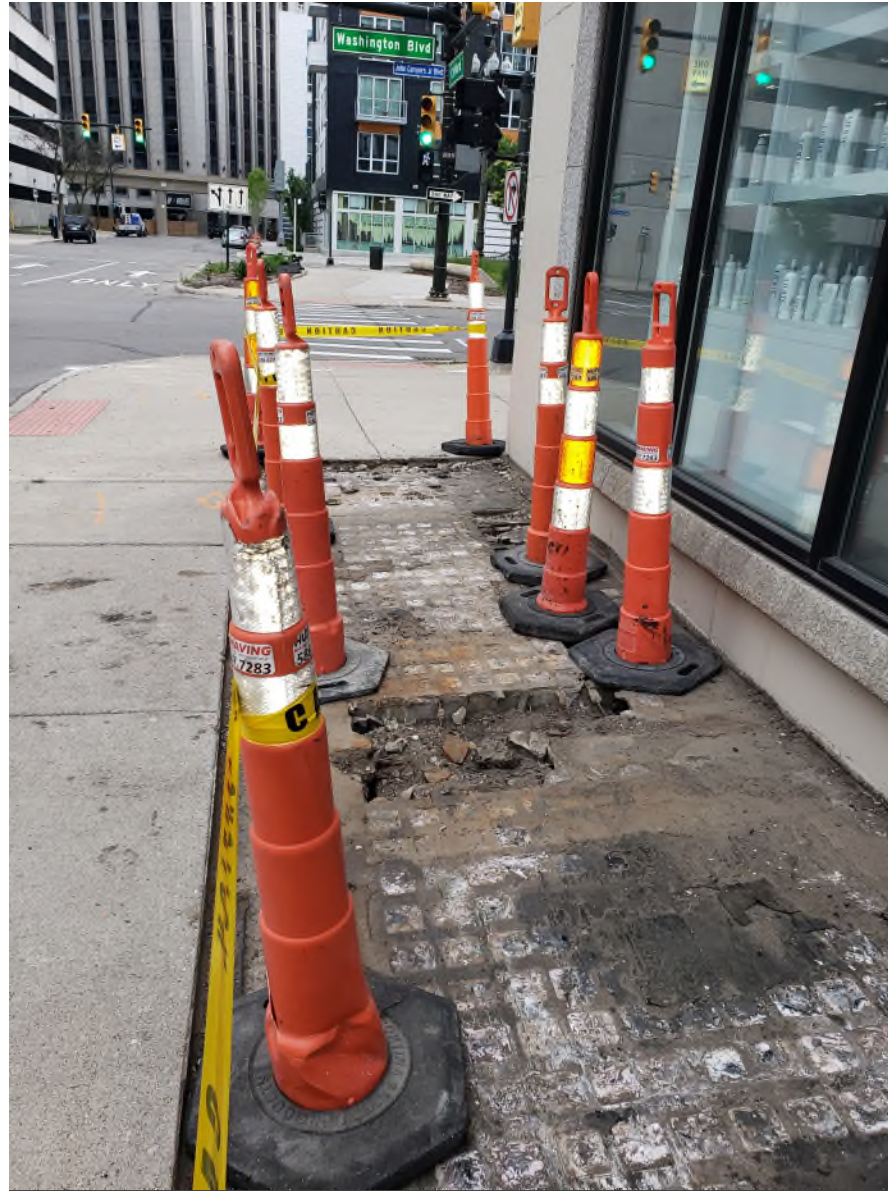
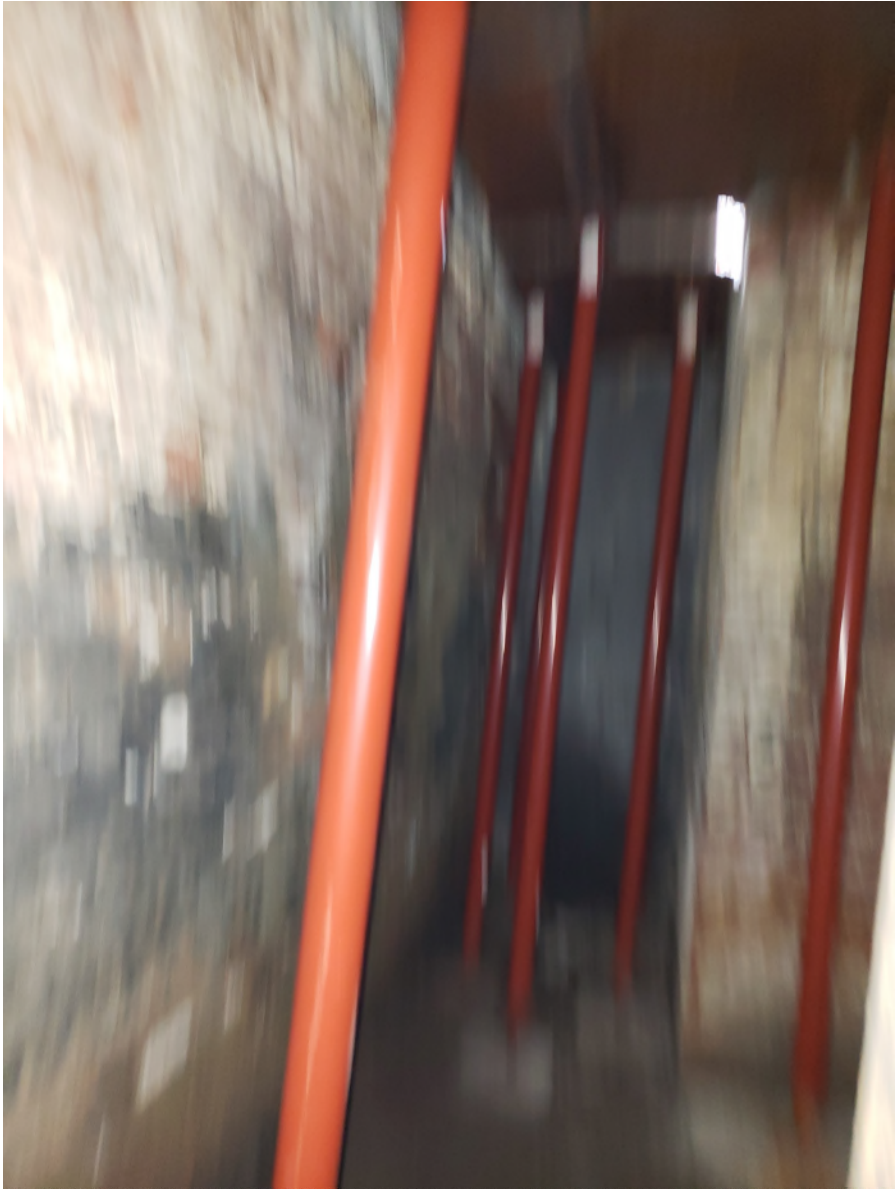
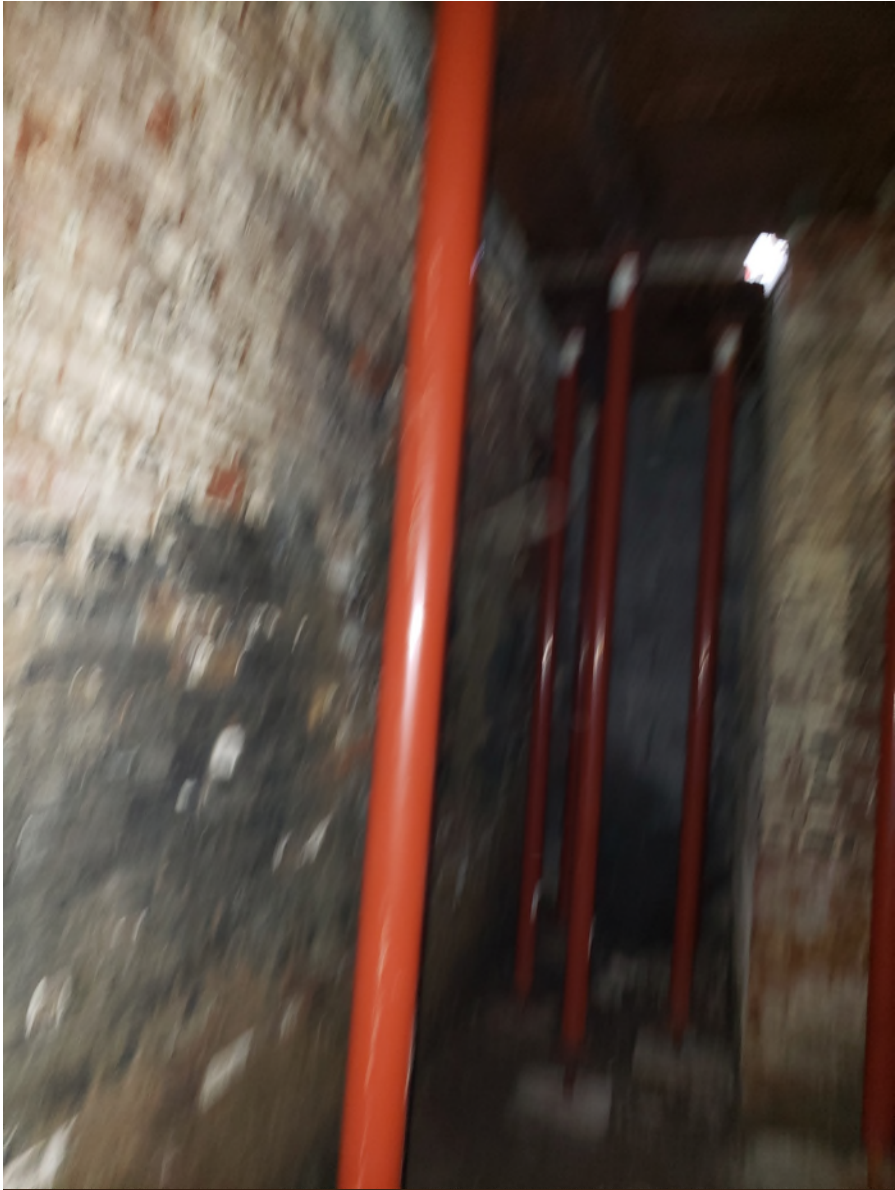
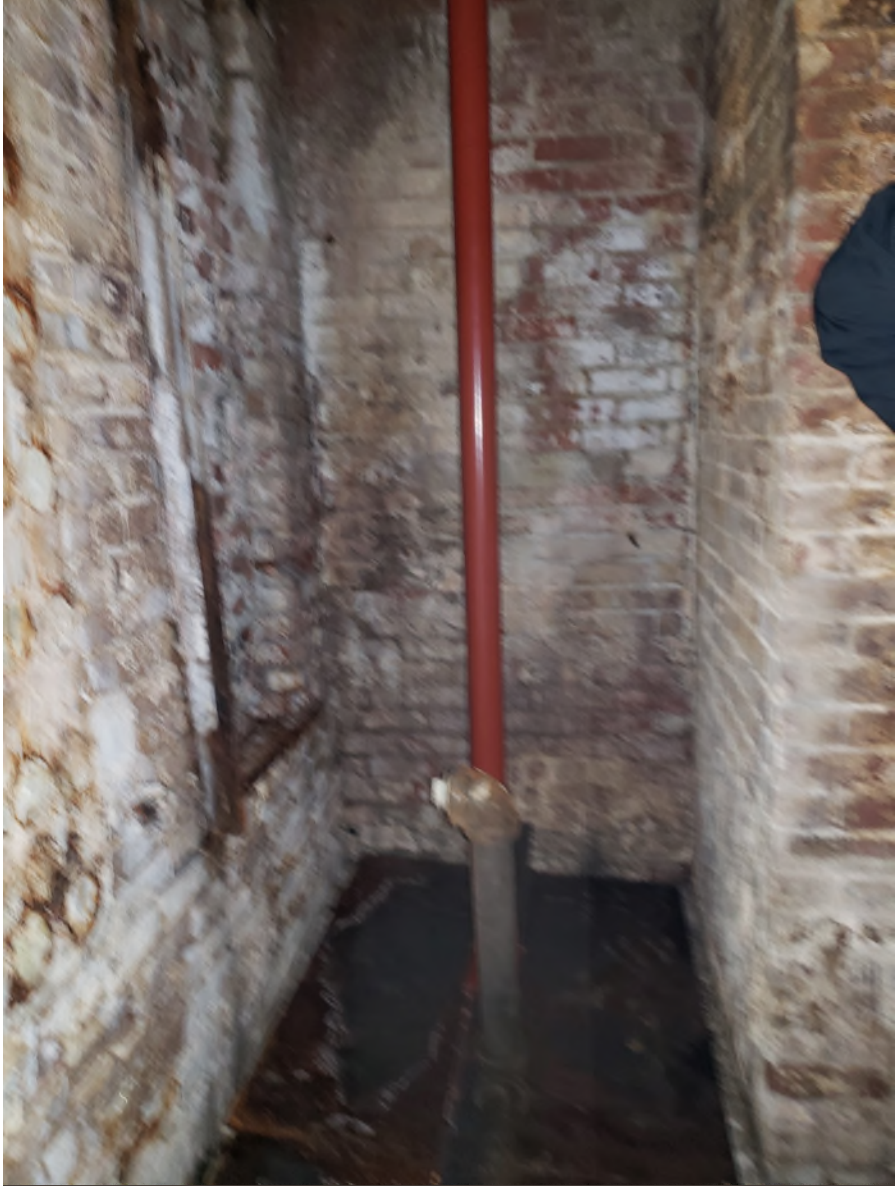
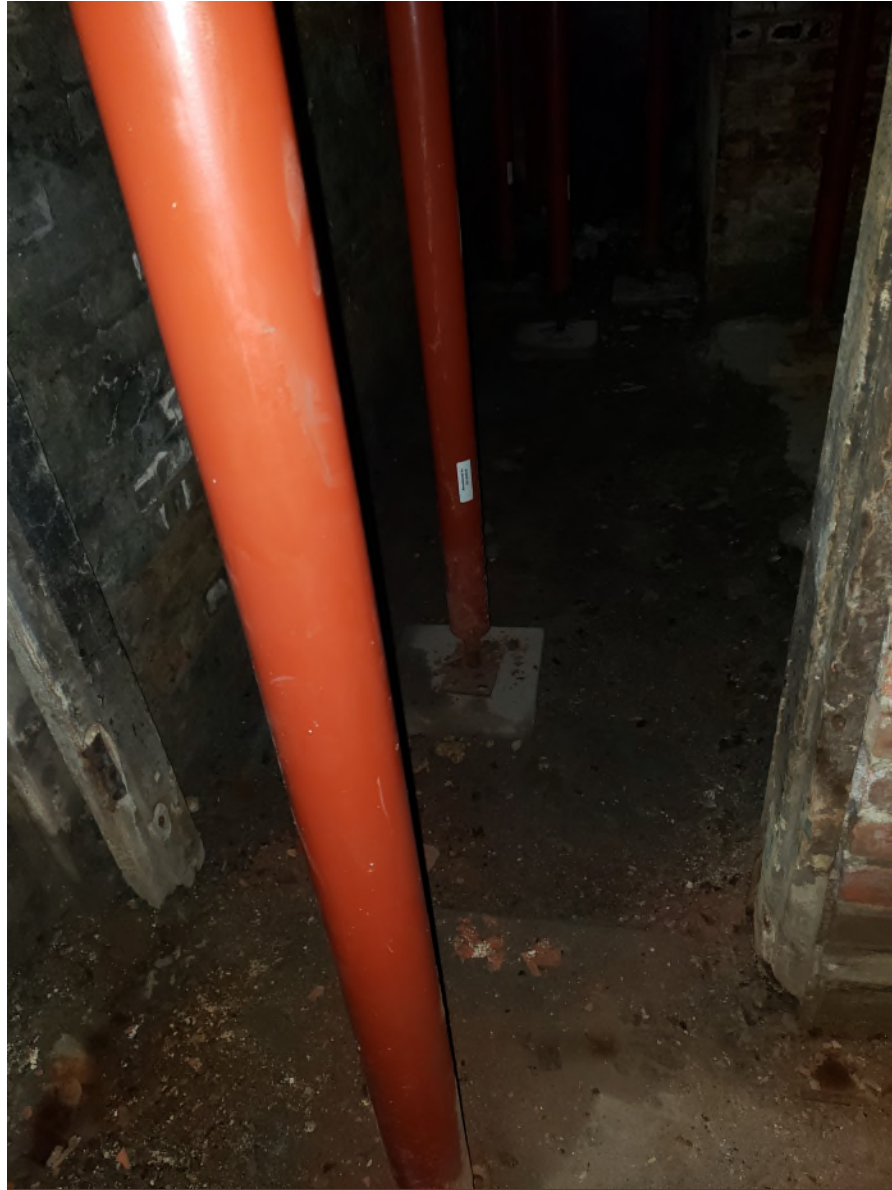
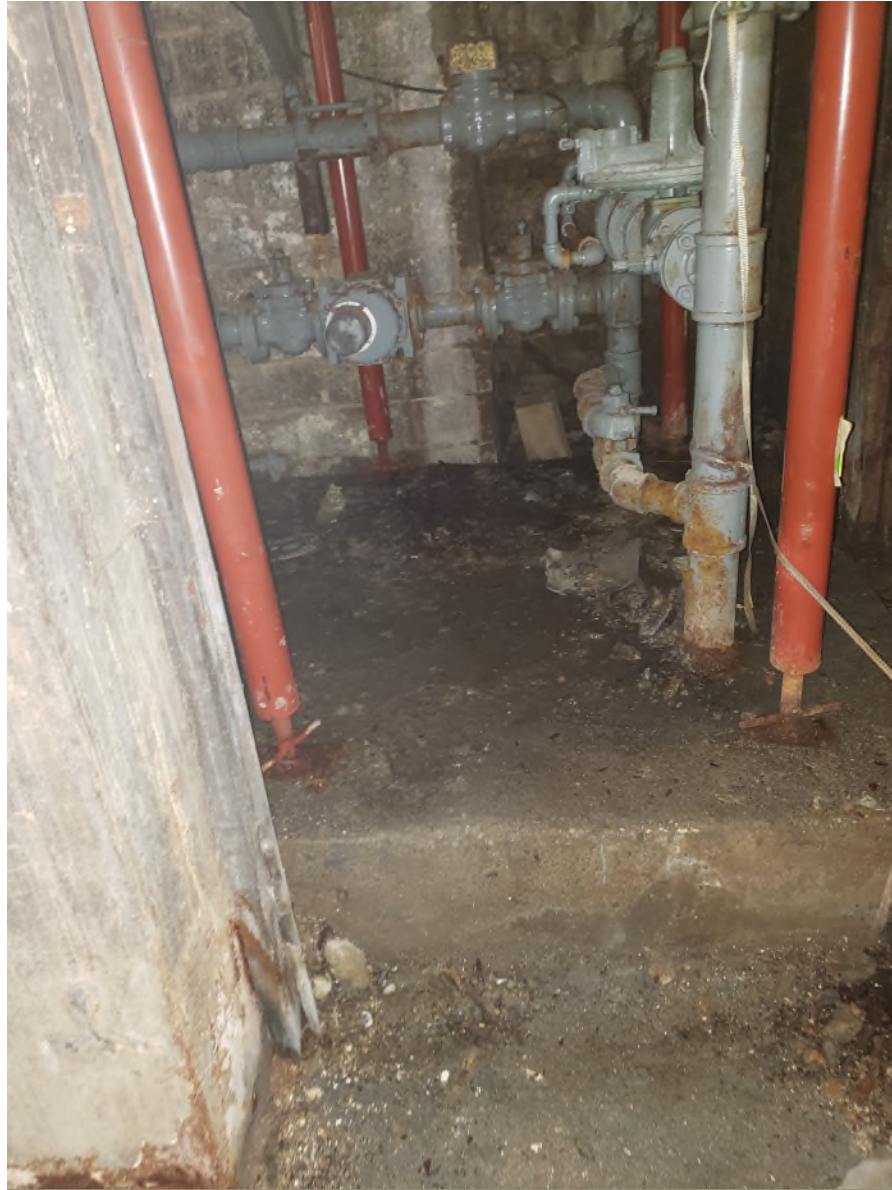
The sidewalk is supported by glass and steel framing from the original building construction. Under the sidewalk the building basement is extended. Overtime the surface material/asphalt patches have deteriorated. Current plan is to repair and recap the sidewalk. Recap consist of cleaning the area, remove asphalt debrie and repatch with concrete.

Based on current field condition review, the column bases are in same condition and adequate for the purpose as it installed. The beams were designed to carry full concrete sidewalk load. Since the original framing is integral to the building foundation and to exterior wall along the sidewalk, it is planned to leave in place, clean up the damaged areas, recap the damaged asphalt with concrete. Based on the field conditions observed and our calculations, it is our opinion that current plan for sidewalk recap is adequate with leaving support system in place.
