02/01/24 ROW Permit Revisions  
Date: Issued For:  
**Sidewalk Vault Repair**  
1427 Randolph Street  
Detroit, Michigan 48226  
**studiozONE : DETROIT**  
architectural | urban | interior DESIGN  
350 Madison Avenue 4th Floor Detroit, Michigan 48226 studiozonedetroit.com 313.549.2790 [a] jpb@ware-house.com

Project Number: 2023  
Sheet Title:  
**VAULT PLAN**  
Sheet Number:  
**SKA 0001**  
© 2023 studiozONE, llc

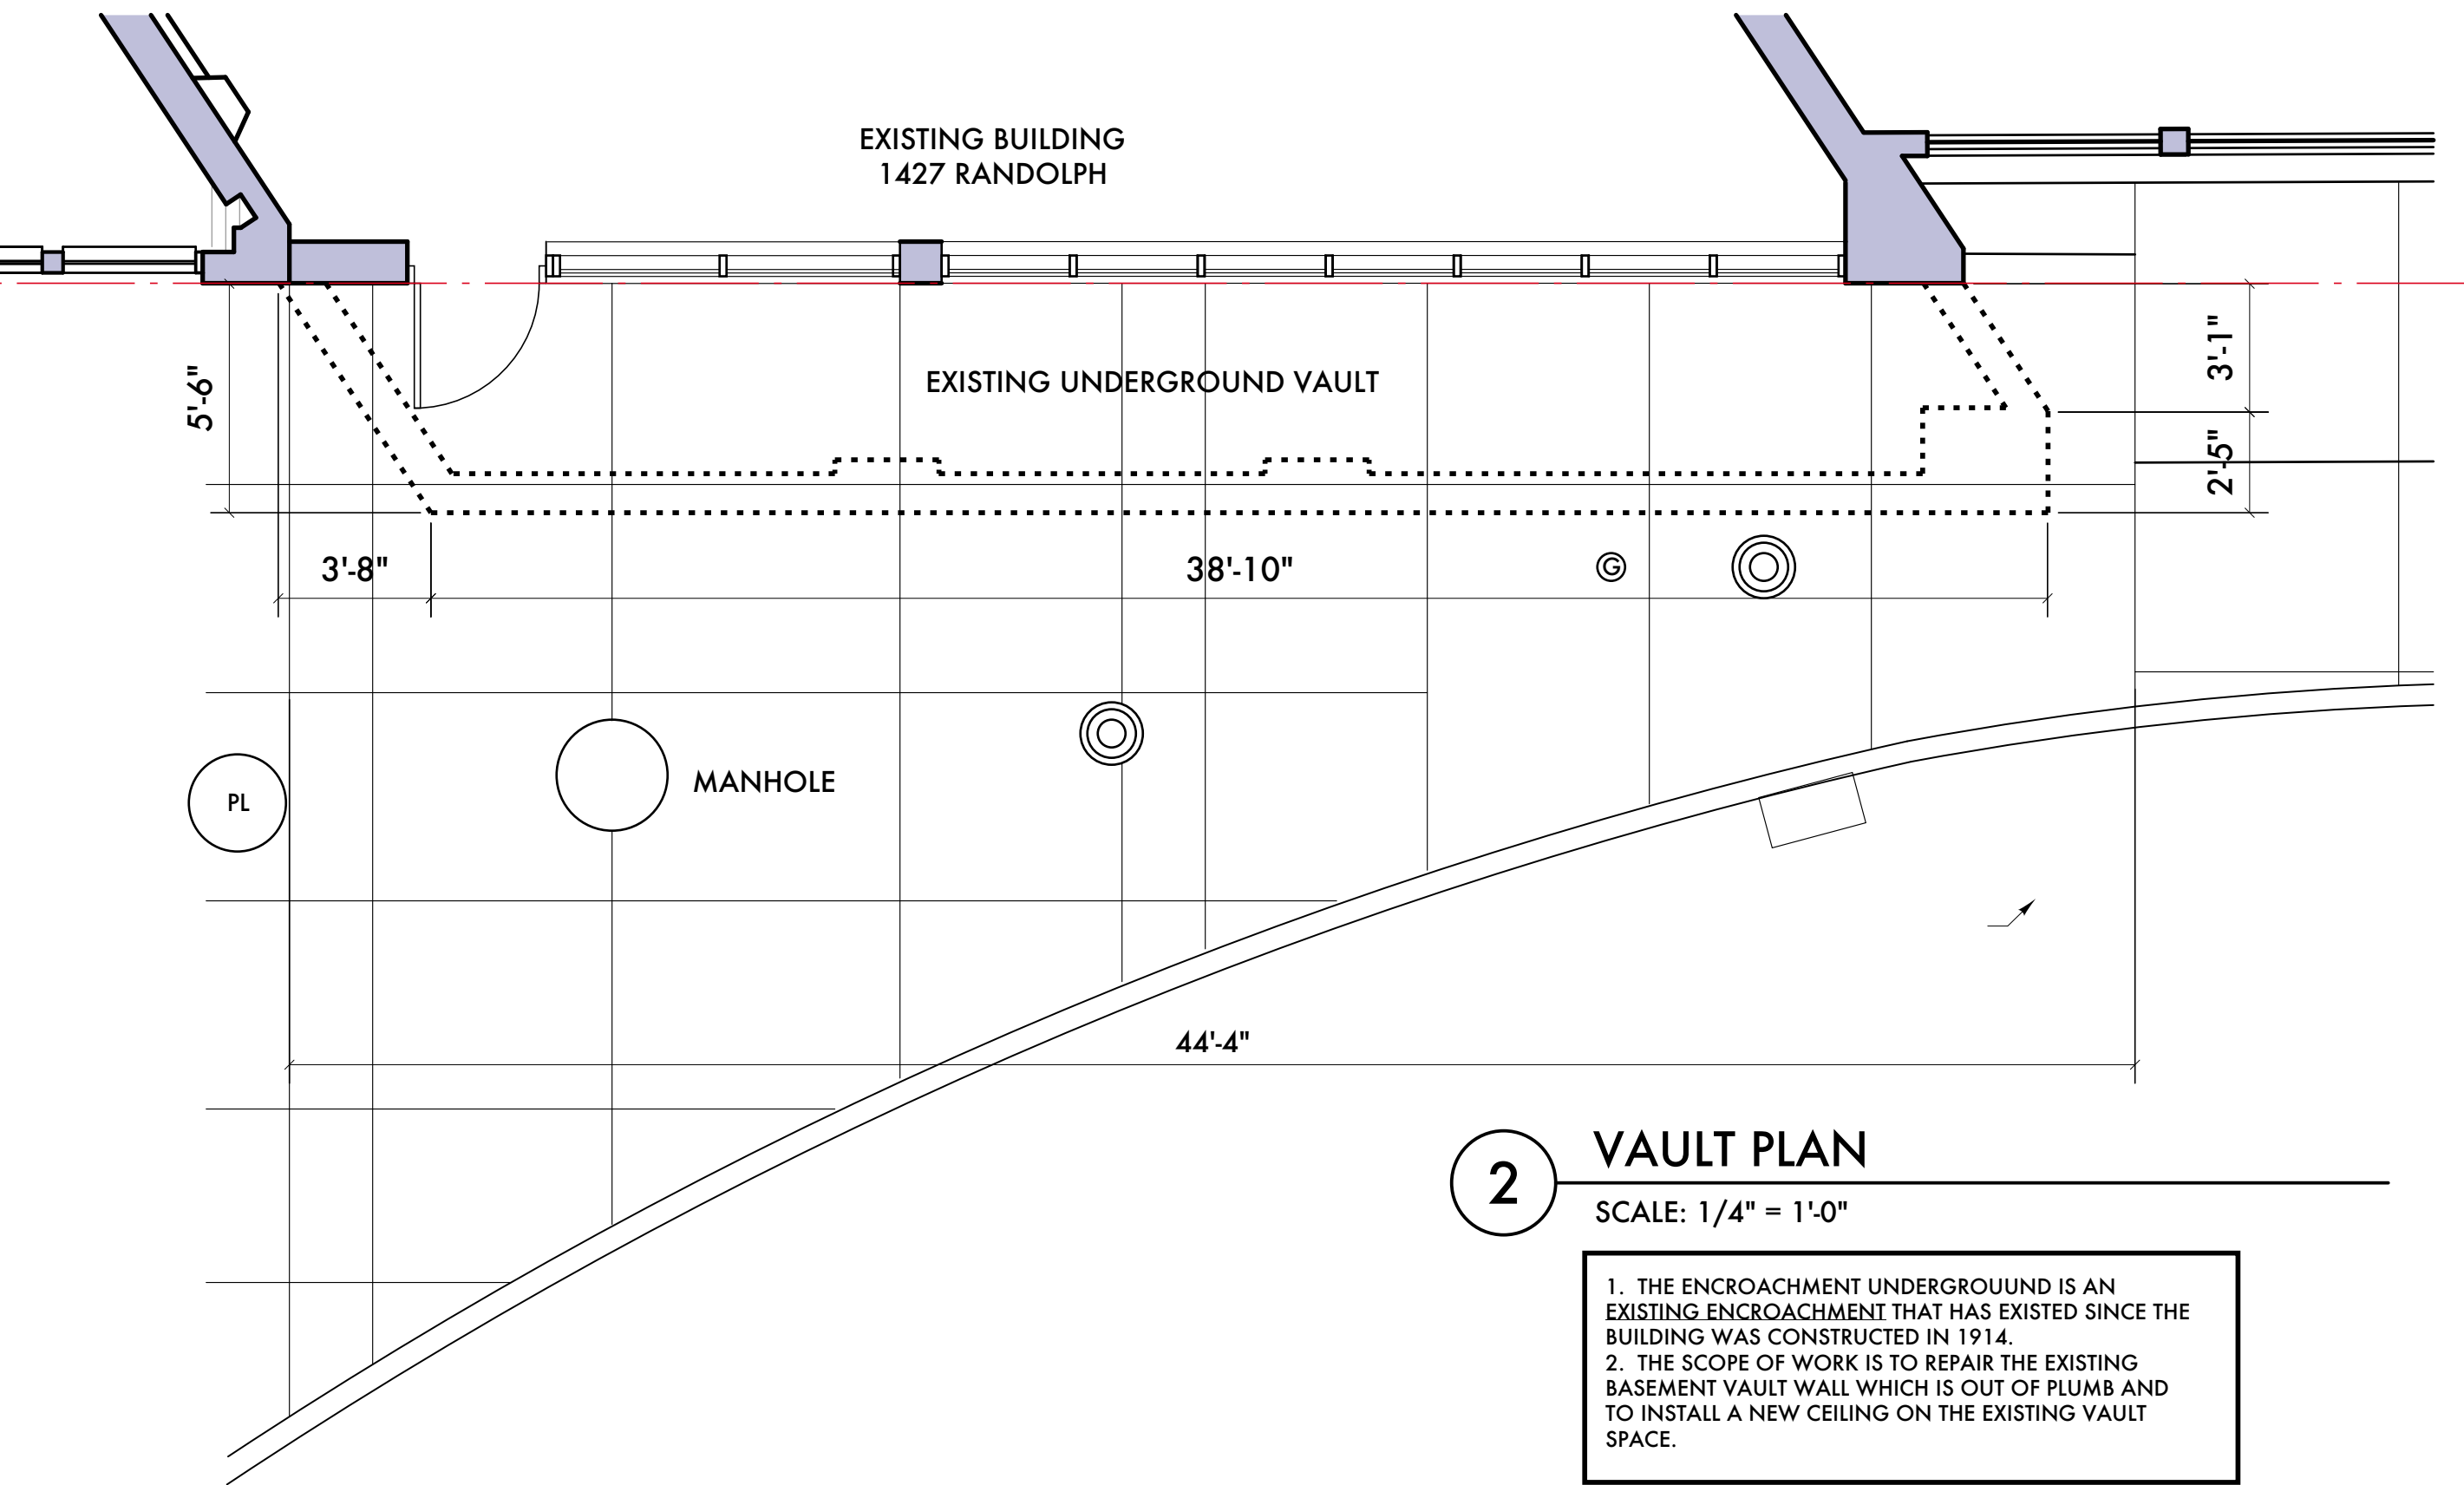
**2 VAULT PLAN**  
SCALE: 1/4" = 1'-0"

EXISTING BUILDING  
1427 RANDOLPH

EXISTING UNDERGROUND VAULT

MANHOLE

1. THE ENCROACHMENT UNDERGROUND IS AN EXISTING ENCROACHMENT THAT HAS EXISTED SINCE THE BUILDING WAS CONSTRUCTED IN 1914.  
2. THE SCOPE OF WORK IS TO REPAIR THE EXISTING BASEMENT VAULT WALL WHICH IS OUT OF PLUMB AND TO INSTALL A NEW CEILING ON THE EXISTING VAULT SPACE.
